## Levee Inspection Report By Mile - Structure 2024

**\*\*\* Preliminary Data \*\*\***

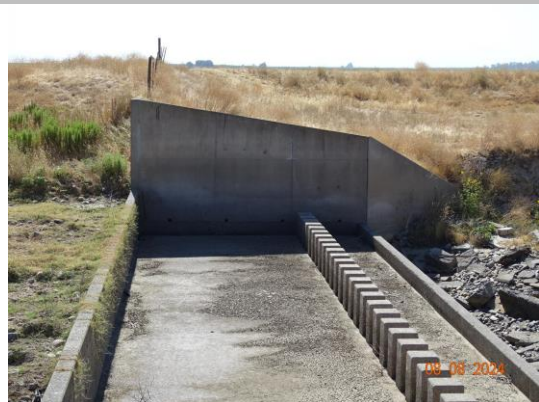
View of the left wing wall. (2024)

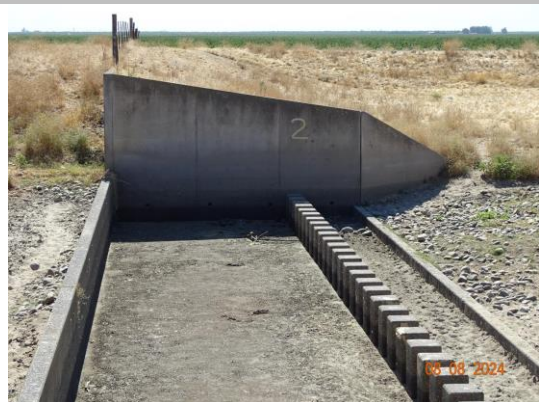
View of left wing wall. (2024)

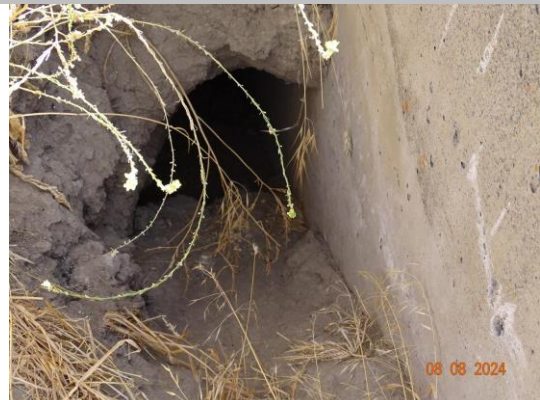
<b>* Location</b> LS : Land Side WS : Water Side CR : Crown	<b>** Rating</b> A : Acceptable M : Minimally Acceptable U : Unacceptable N : Not Inspected/Rated C : Corrected A/W : Acceptable but Monitor & Maintain	<b>+ Issue Type</b> Ma : Maintenance Deficiency Ob : Design & System Obsolescence En : Enforcement	97 25 35
--	---	---	----------------

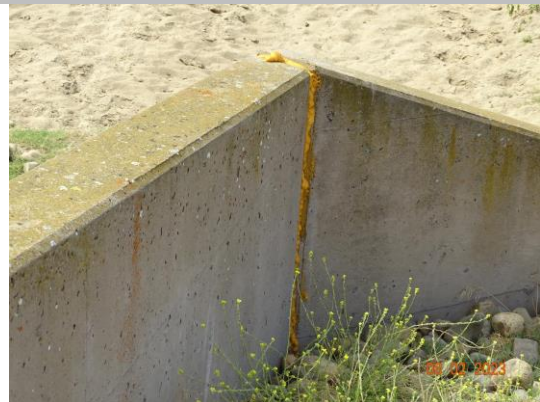
Representative view of repaired monolith joints. (2023)

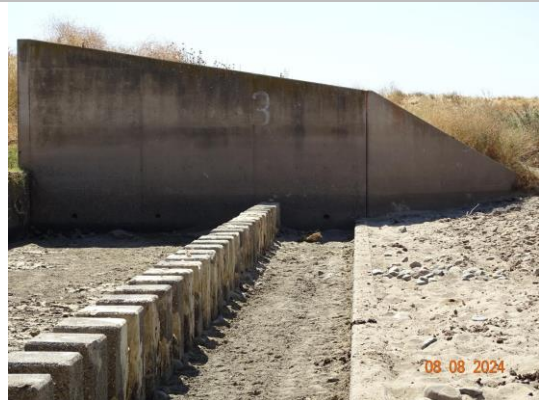
View of the left wing wall. (2024)

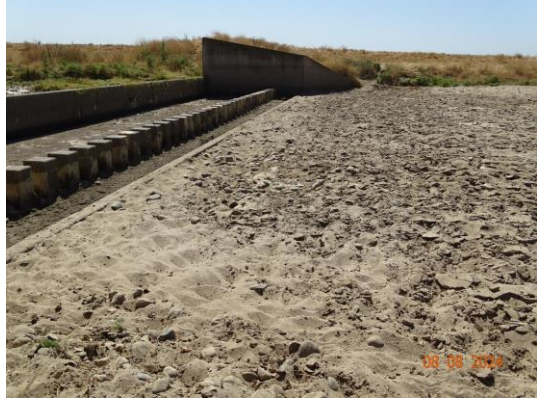
Downstream view of revetment, mostly obscured by sedimentation. (2024)

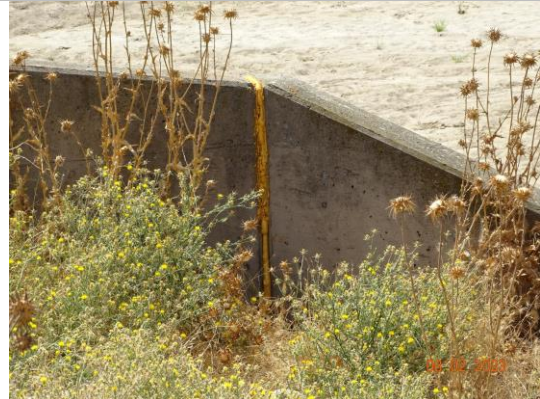
Representative view of repaired monolith joint. (2023)

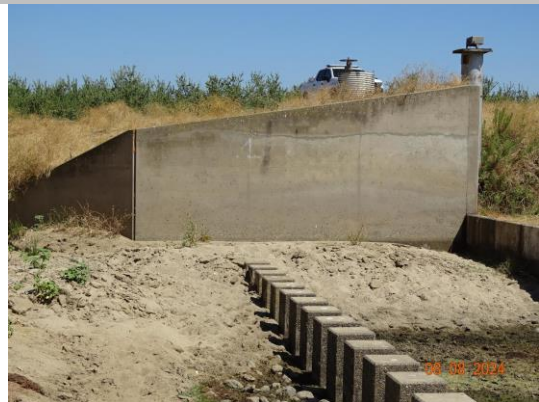
View of the right wing wall. (2024)

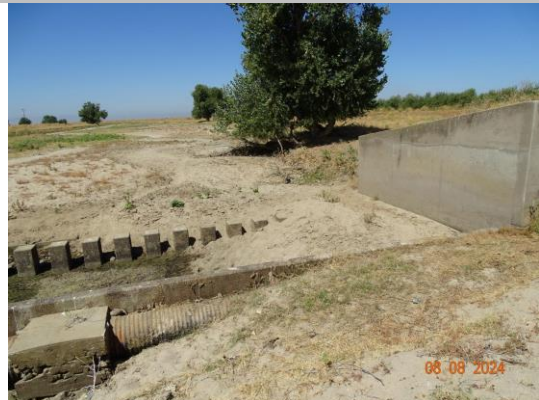
Sedimentation downstream along the right wall. (2024)

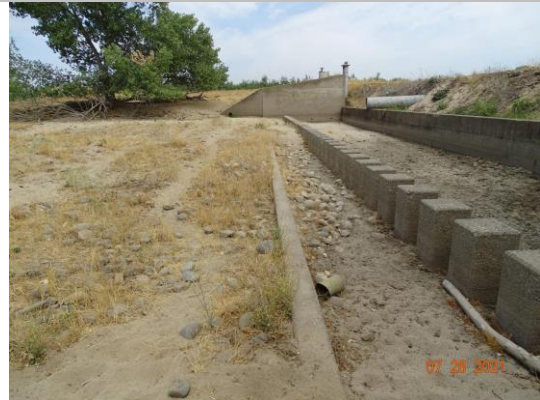
View of downstream revetment looking towards the right wing wall. (2021)

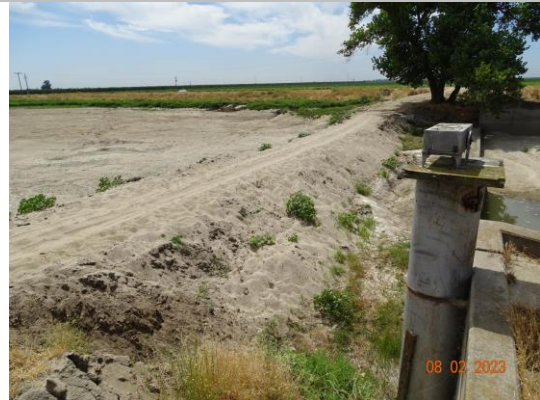
View along unauthorized sand dam from the right bank. (2023)

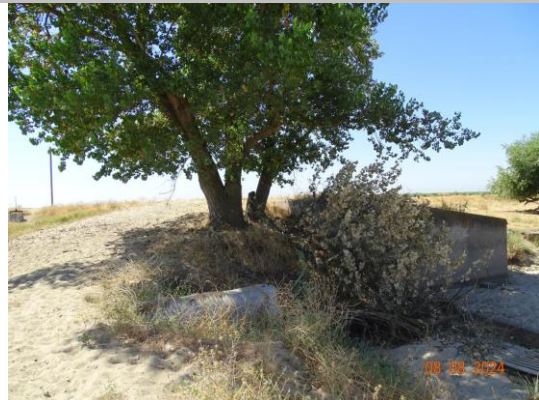
View of the unauthorized pipes through the unauthorized earthen dam. (2024)

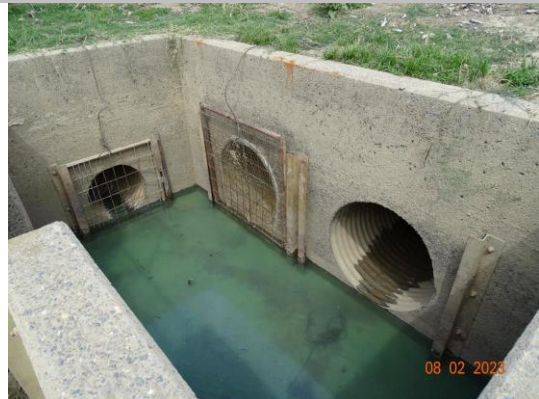
View of inlet on the right bank. (2023)

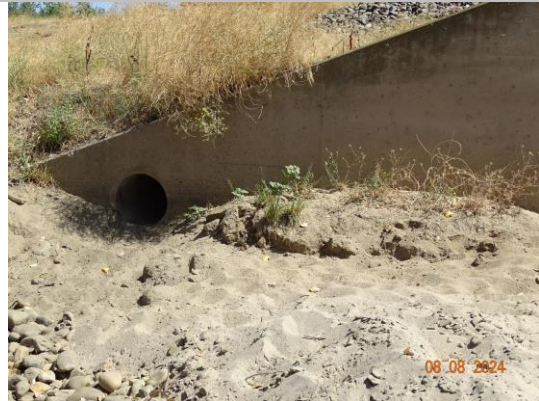
View of outlet at the right wing wall. (2024)

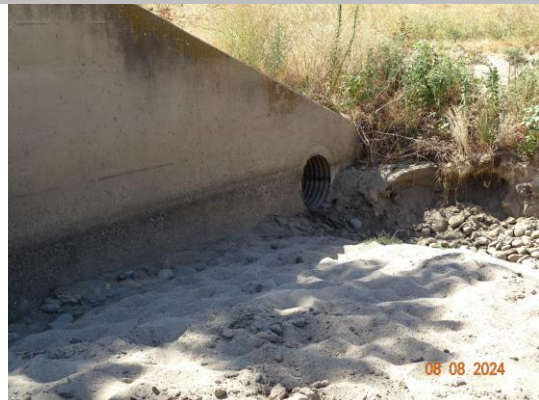
View of outlet at the left wing wall. (2024)

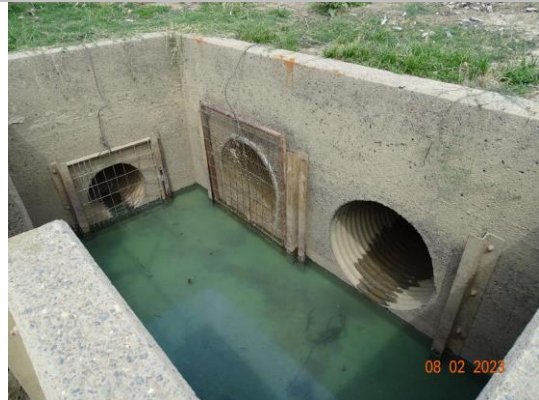
Inlet for right wing wall CMP. (2023)

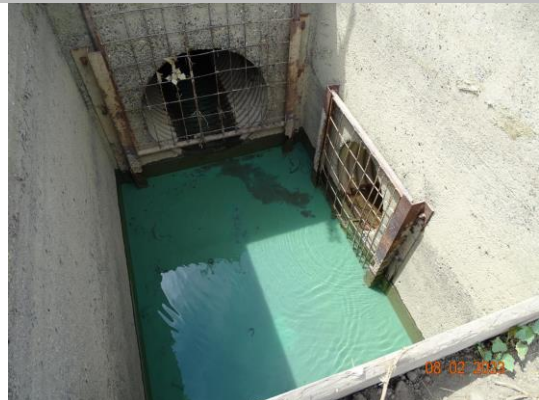
Inlet for left wing wall CMP. (2023)

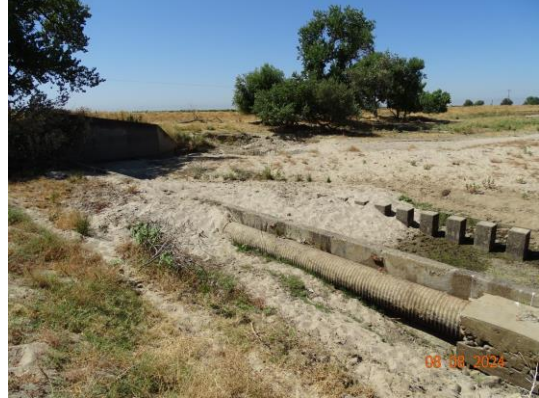
CMP that connect between culverts risers on left and right wing wall. (2024)

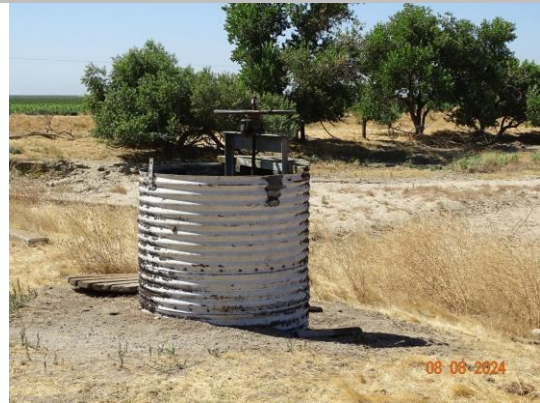
View of the gate operator on the right bank. (2024)

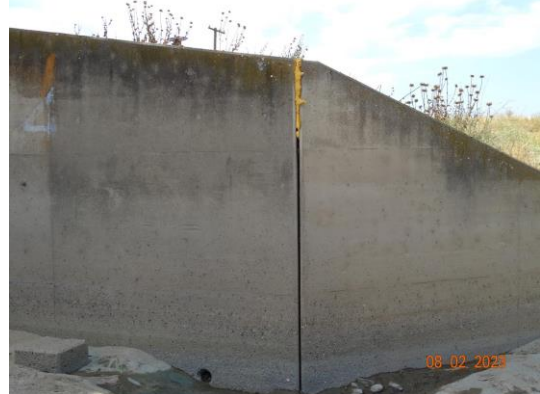
Representative view of repaired monolith joint. (2023)

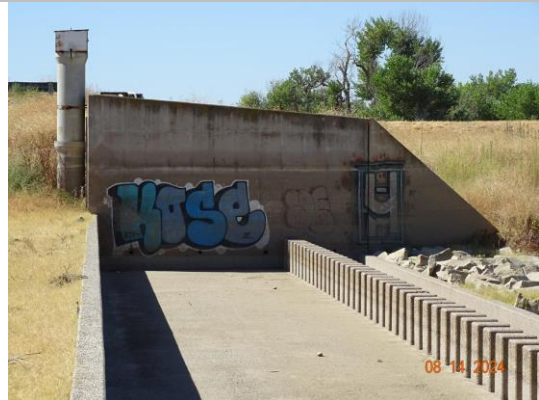
View of the left wing wall. (2024)

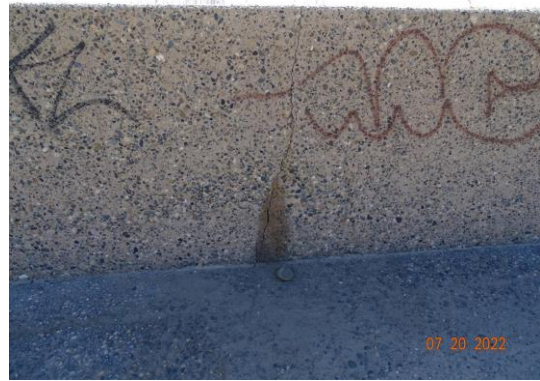
Small crack at head wall. (2022)

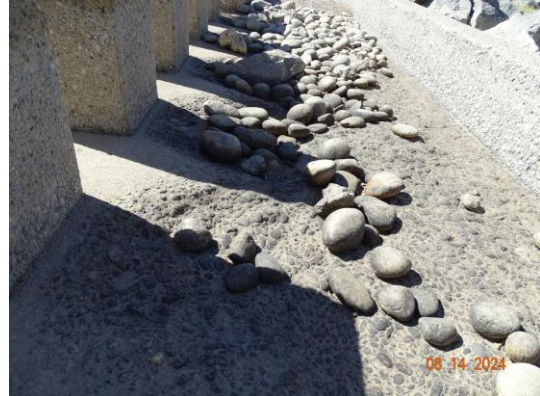
Scour along the base concrete downstream of the dissipators. (2024)

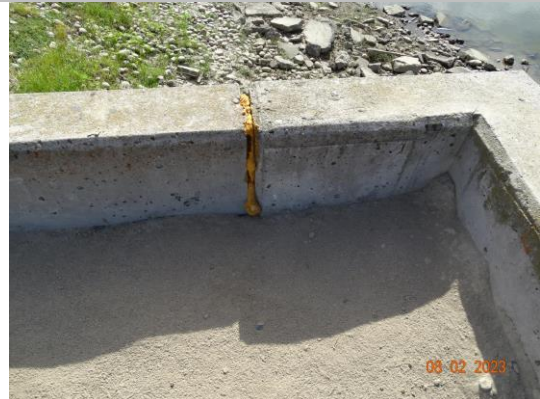
Representative view of the repaired monolith joints. (2023)

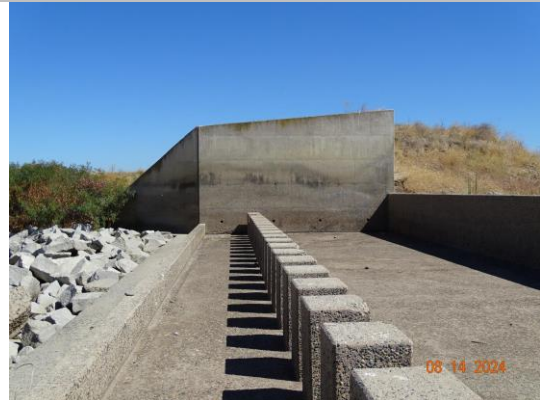
View of the right wing wall (2024)

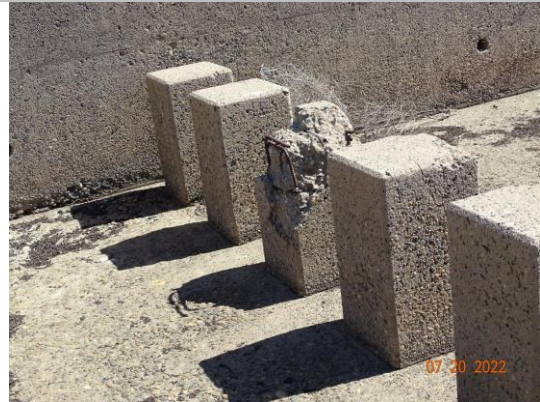
Dissipator near right wing wall is damaged. (2022)

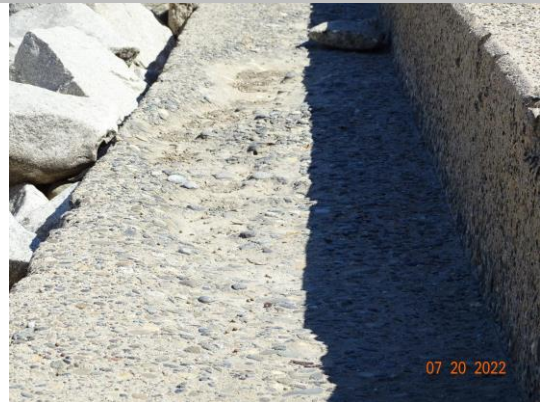
Minor spalling on lip just upstream of the revetment. (2022)

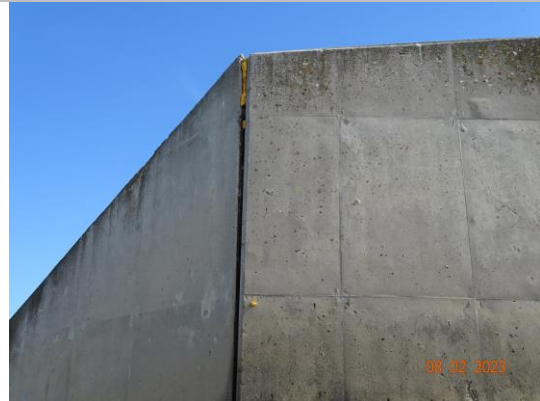
Representative view of the monolith joints at this structure. (2023)

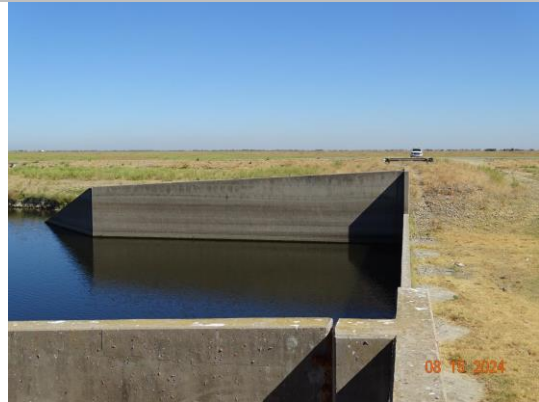
View of the right wing wall. (2024)

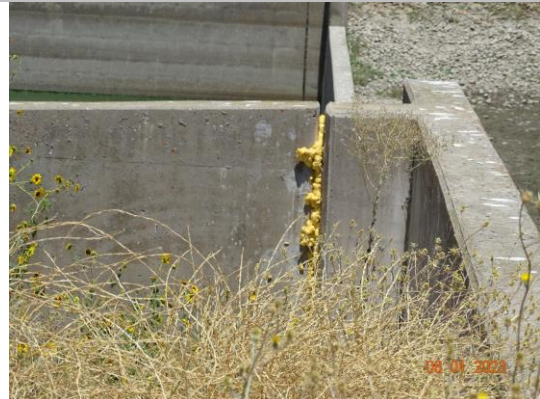
View of repaired monolith joint at the left headwall. (2023)

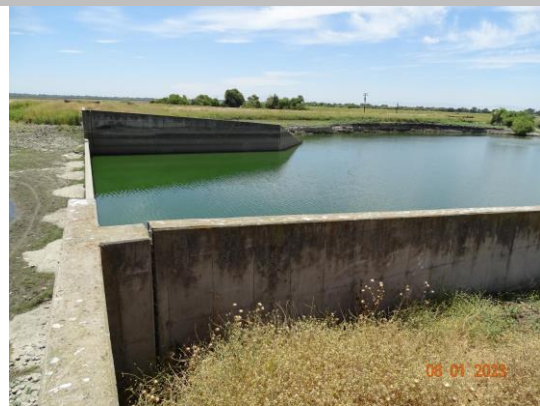
View of right headwall joint deterioration. (2023)

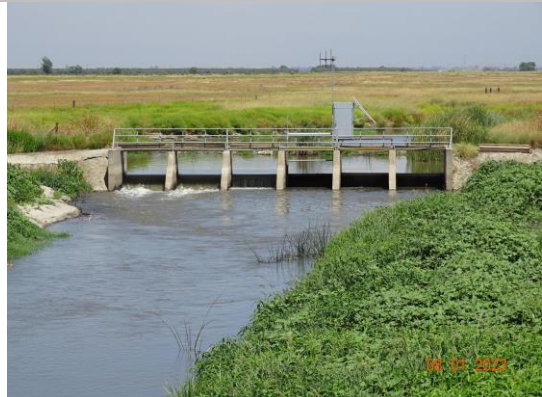
Overview of the structure from the downstream channel. (2023)

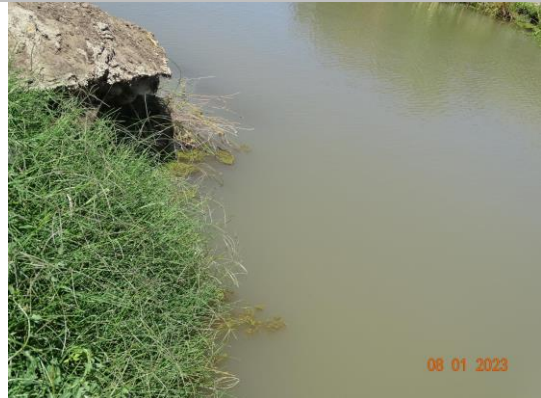
View of erosion at left bank on the upstream side of the structure. (2023)

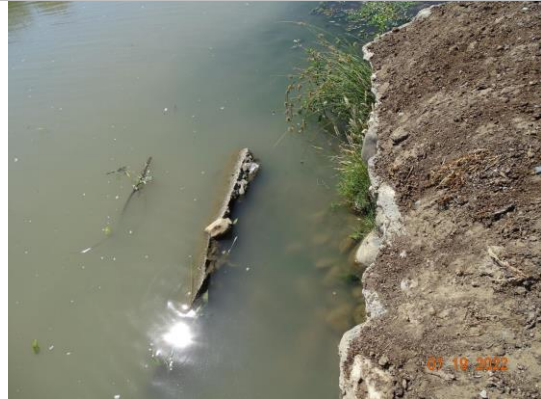
Piece of concrete broken off from the left upstream bank. (2022)

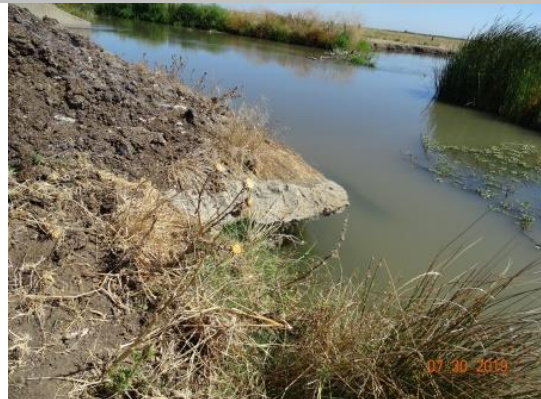
View of erosion at left bank on the upstream side of the structure. (2019)

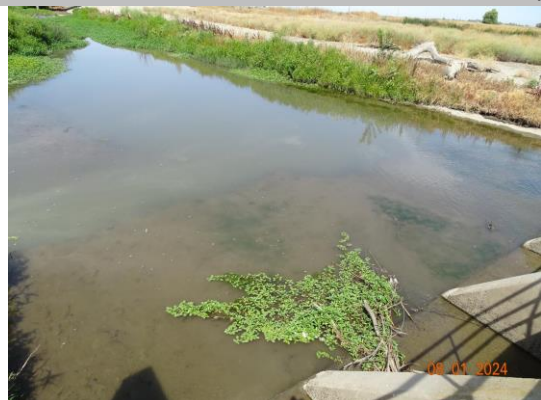
Erosion of the downstream revetment. (2024)

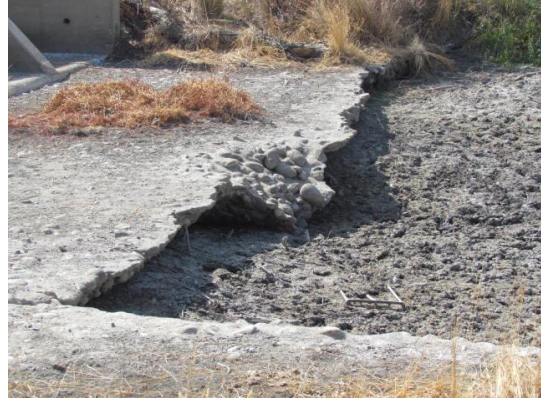
Looking at minor revetment erosion on downstream side of structure. (2015)

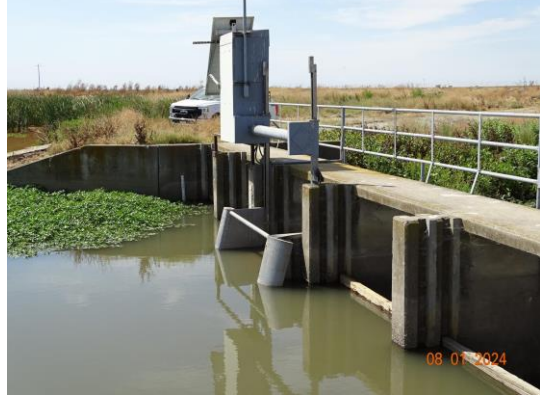
View of the electric gate operator on the upstream side of the structure. (2024)

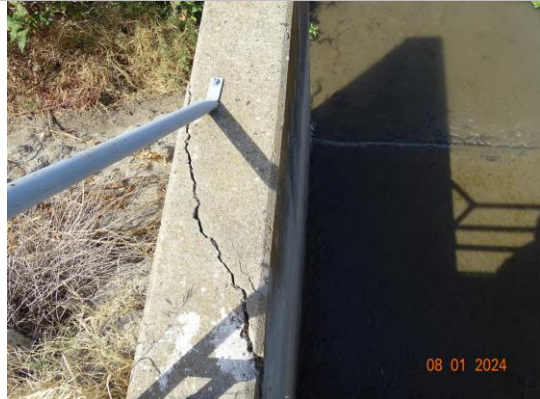
View of crack on the left wing wall. (2024)

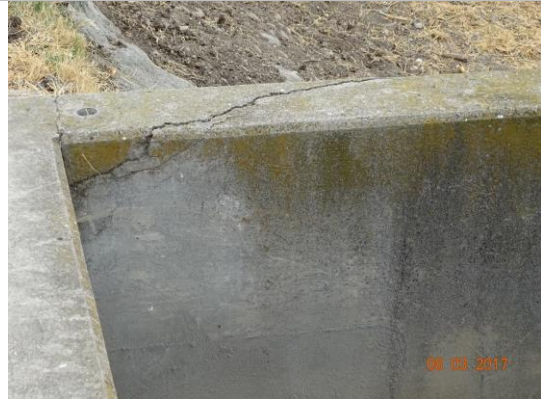
Cracking on left wing wall. (2017)

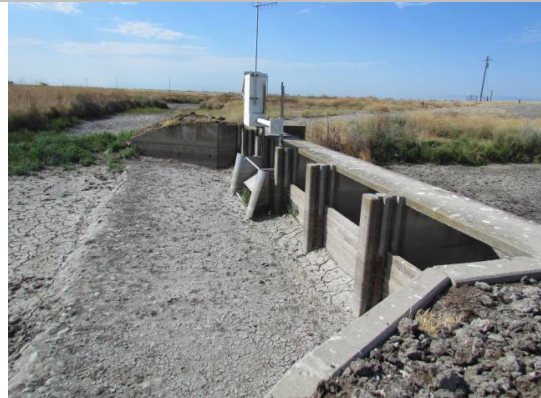
Looking at upstream side of structure.

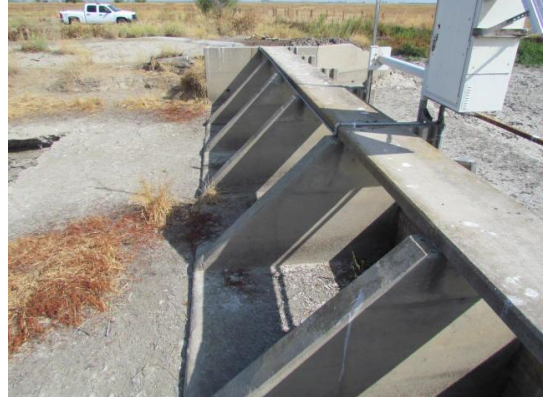
Looking at downstream side of structure.

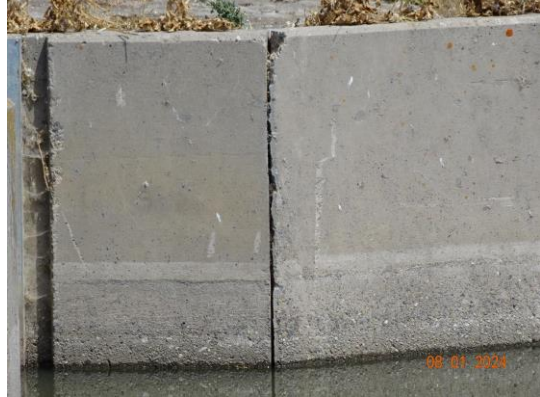
Deteriorated joint on the right headwall. (2024)

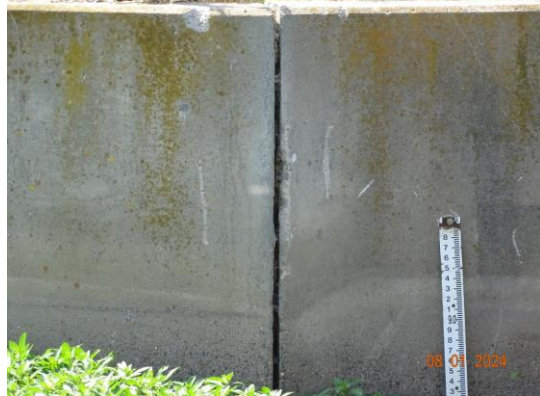
Deteriorating joint on the left headwall. (2024)

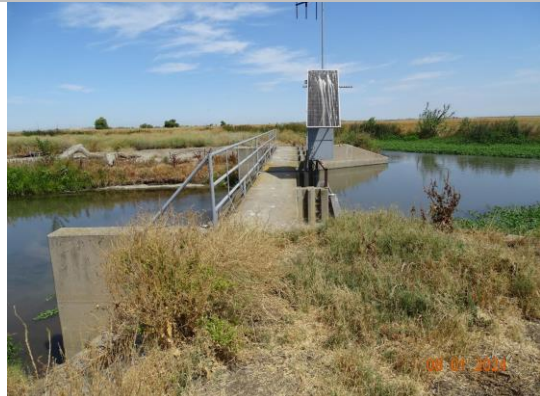
Handrails on the downstream side of the structure. (2024)

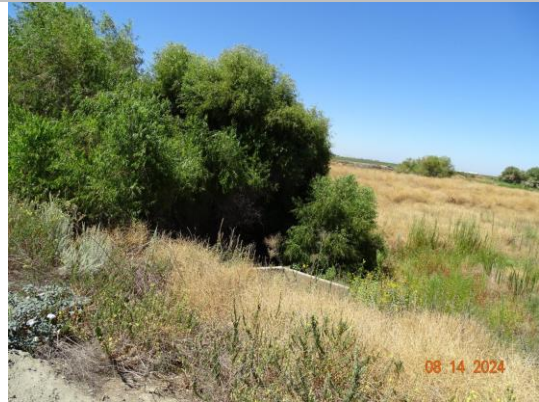
View of the outlet side of the structure. (2024)

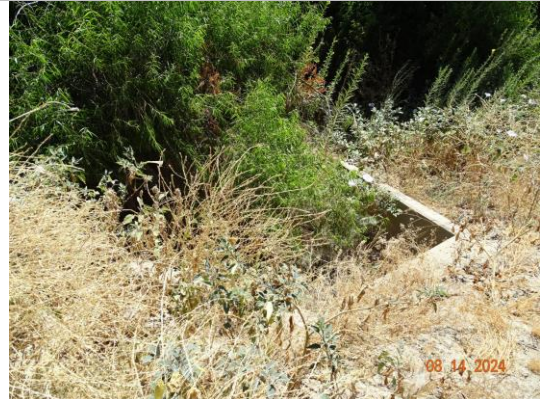
View of inlet side of structure. (2024)

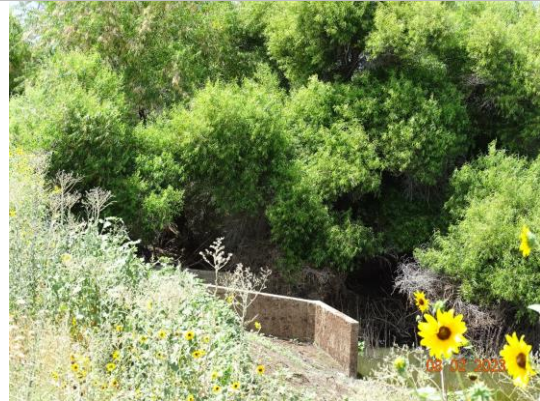
View of outlet side of structure. (2023)

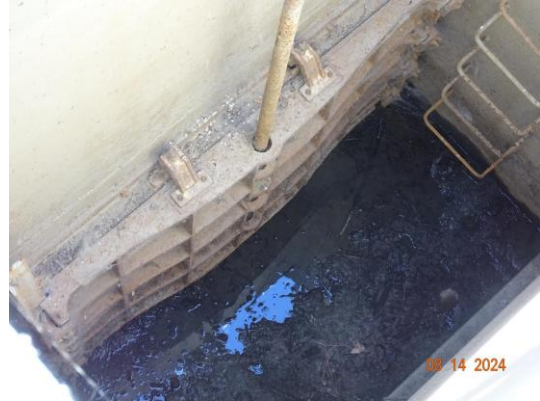
View of slide gate. (2024)

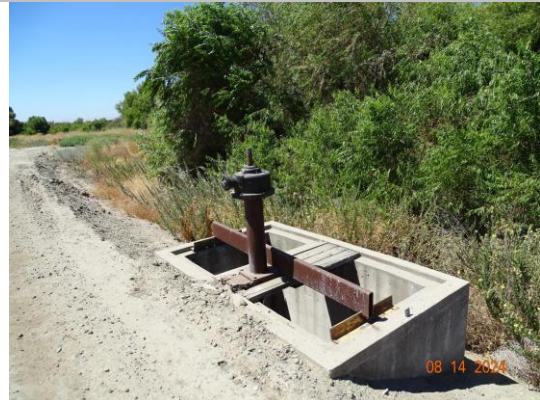
View of the manual gate operator. (2024)

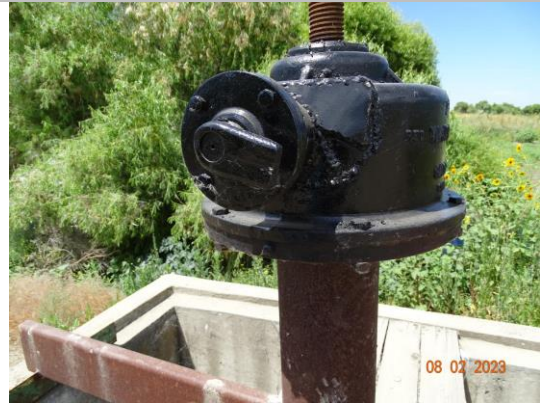
View of the broken crank arm. (2023)

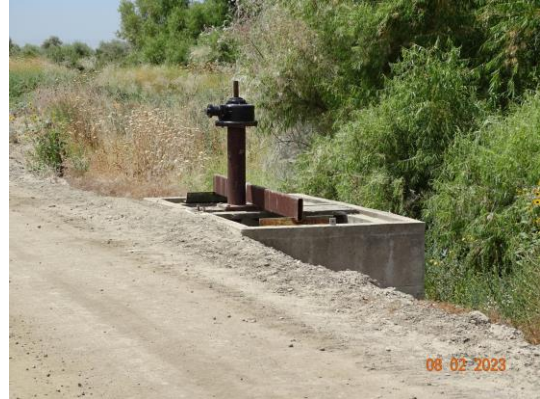
View of manual gate operator at the levee crown. (2023)

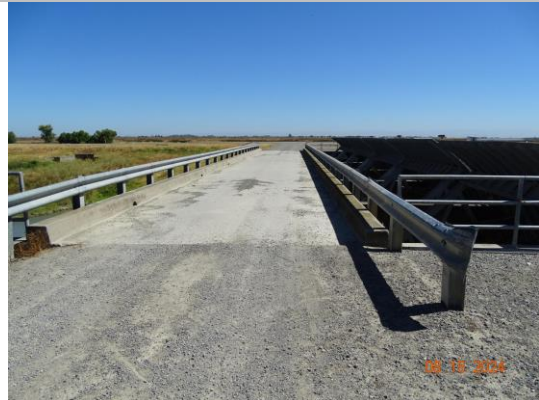
View across the top of the structure from the left bank. (2024)

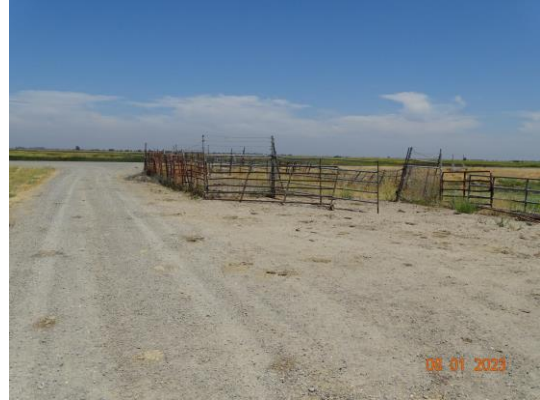
View of animal pen looking towards the right bank. (2023)

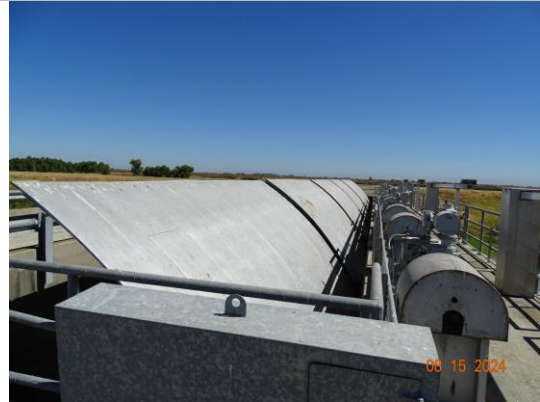
View of the control gates. (2024)

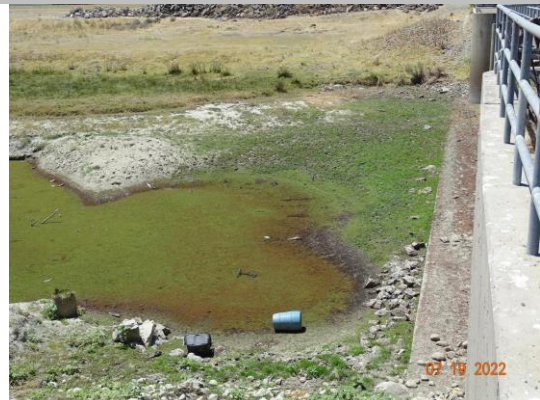
Looking at the upstream side of the structure. (2022)

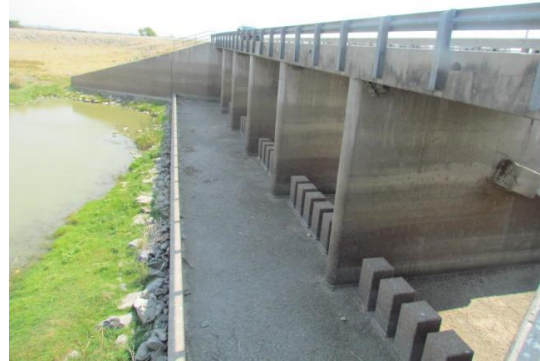
Looking at downstream side of structure. (2017)

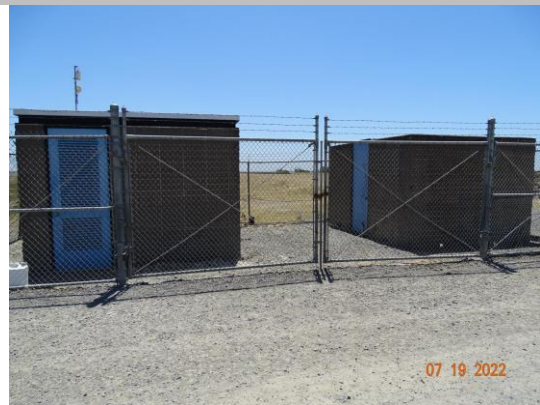
View of fencing around the electrical housing. (2022)

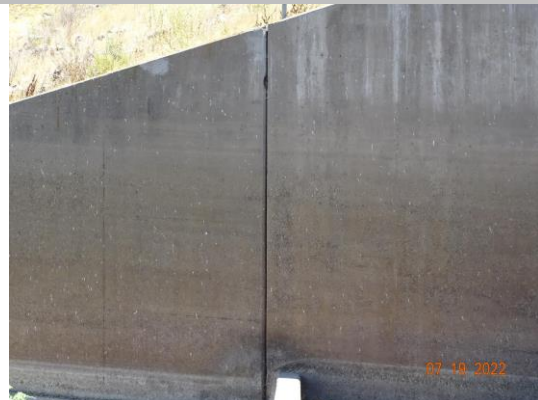
View of monolith joint at right wing wall. (2022)

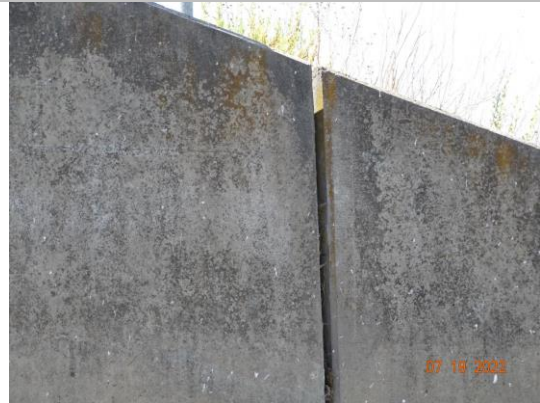
View of monolith joint at left wing wall. (2022)

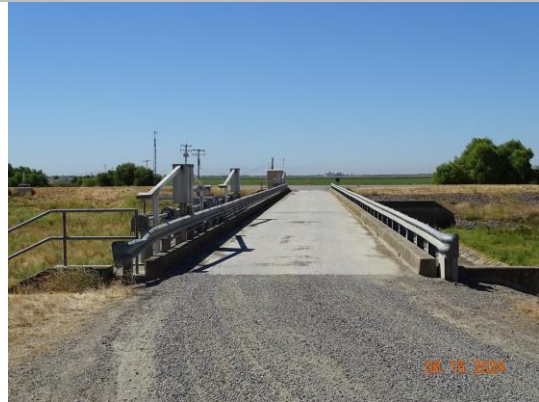
View across the top of the structure. (2024)

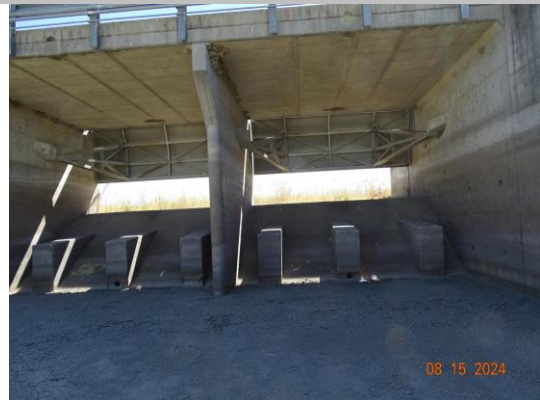
Typical view of outlets. (2024)

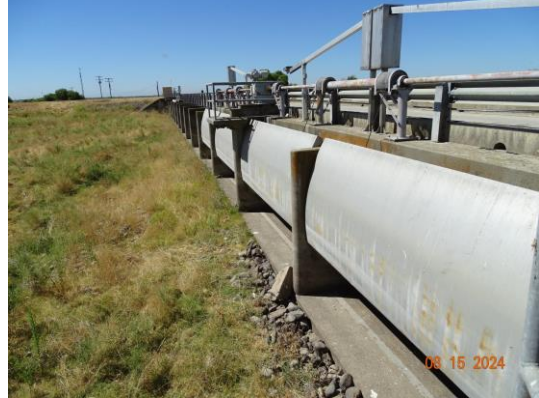
View of the right radial gates. (2024)

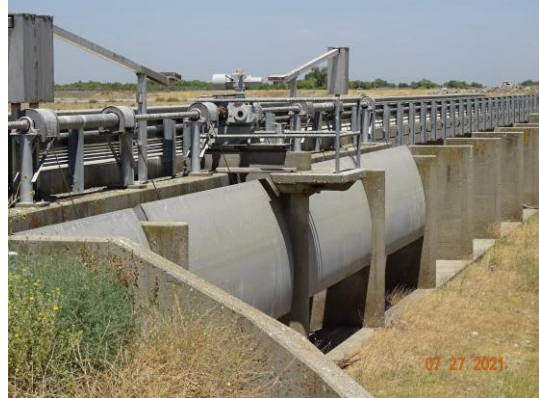
View of the left radial gates. (2021)

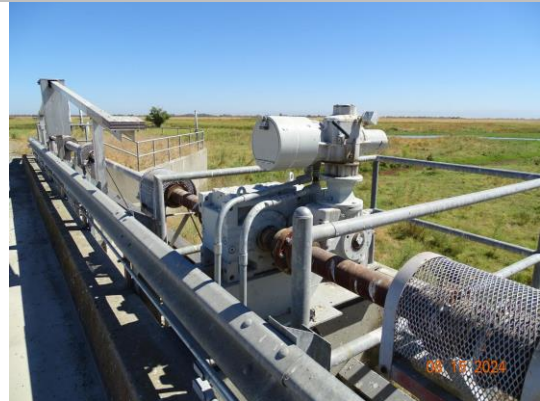
Typical view of electrical gates on upstream side of structure. (2024)

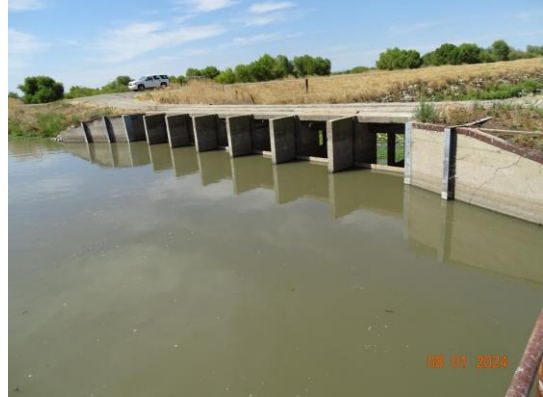
View of the upstream side of the structure. (2024)

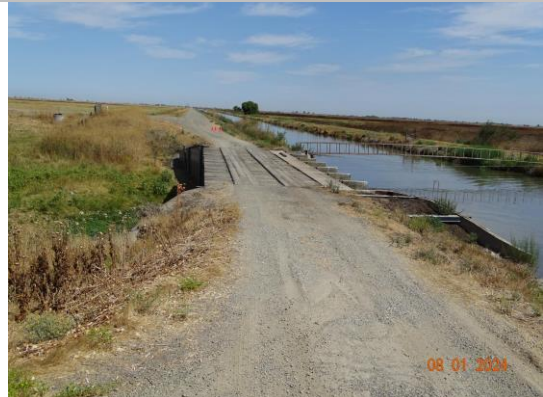
View across the top of the structure. (2024)

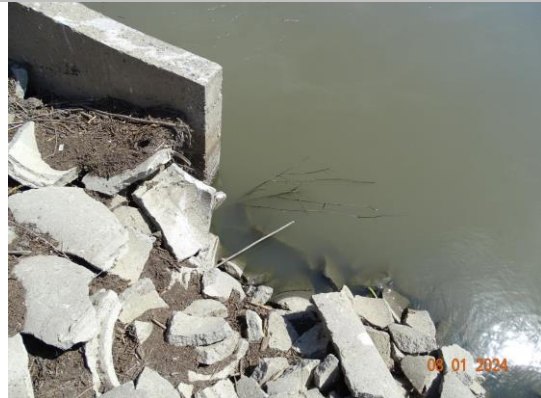
View of concrete revetment place at the left upstream wingwall. (2024)

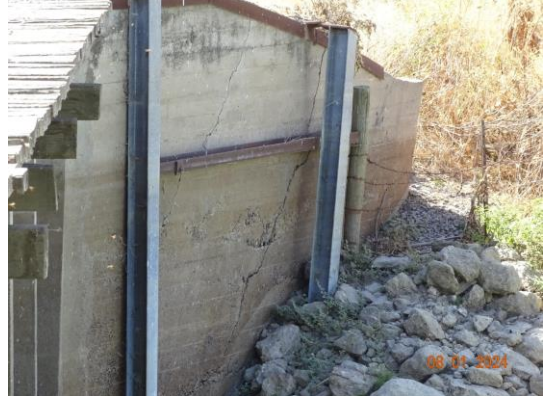
Looking at crack on left wing wall on downstream side of structure. (2024)

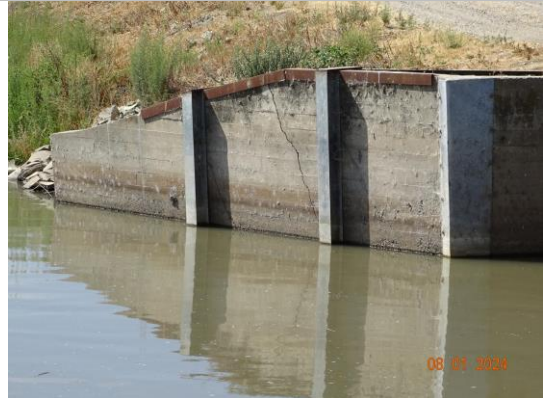
Cracking on the left headwall of the structure. (2024)

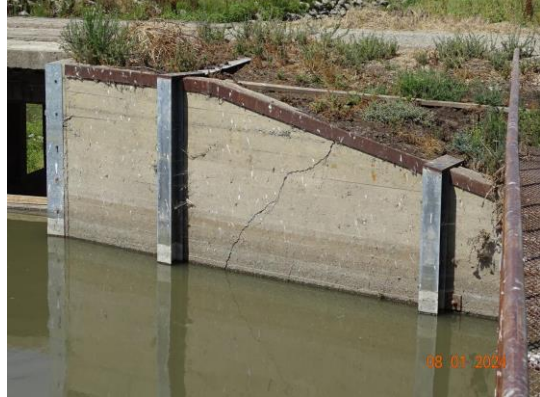
Cracking on the right headwall of the structure. (2024)

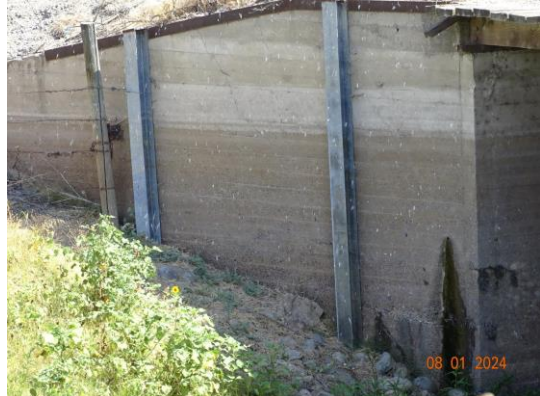
Looking at small crack on right wing wall on downstream side of structure. (2024)

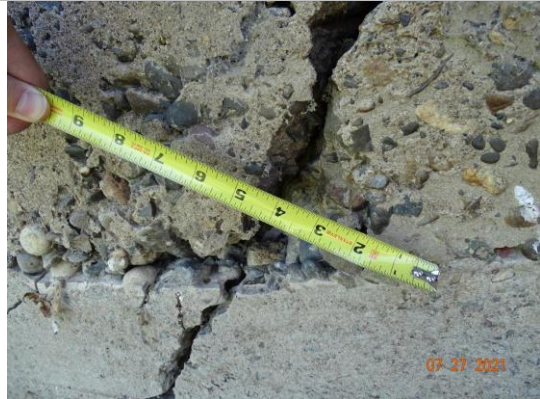
Measurement of crack at the widest section on left downstream wing wall. (2021)

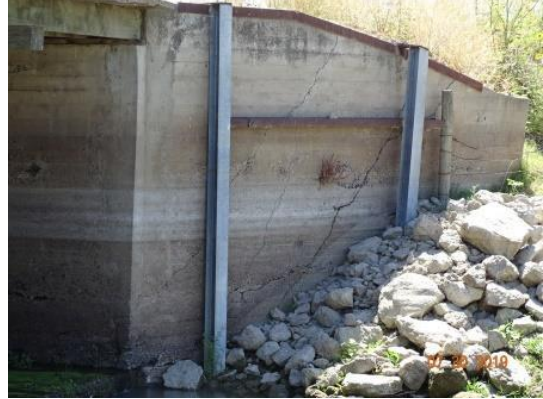
Looking at crack on left wing wall on downstream side of structure. (2019)

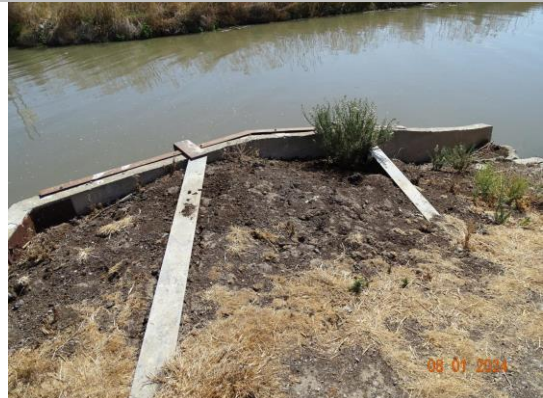
Looking at upstream left wing wall. (2024)

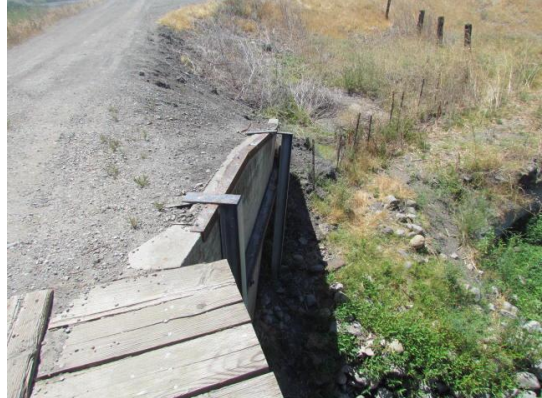
Looking at brace on left wing wall on downstream side of structure. (2012)

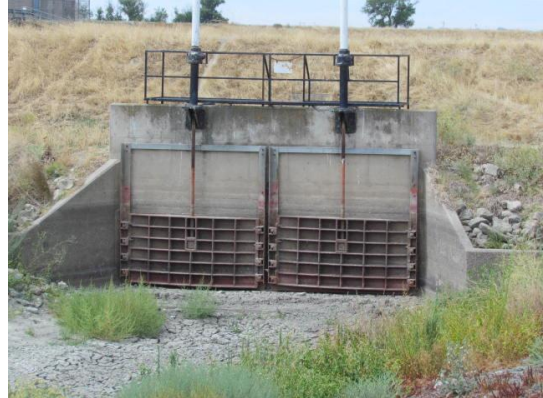
Looking at upstream side of structure. (2015)

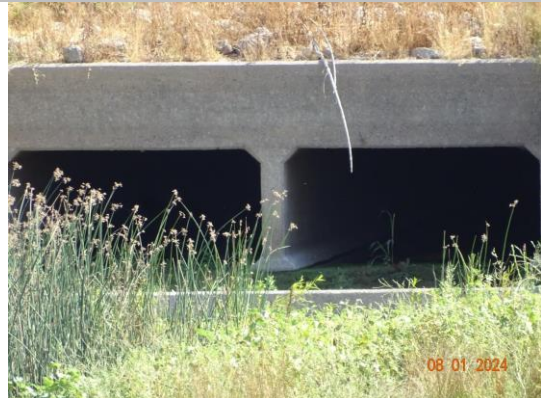
View of the structure outlets. (2024)

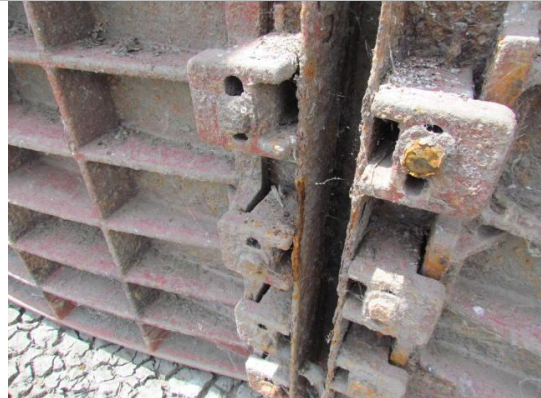
Looking at corrosion on slide gates on upstream side of structure. (2015)

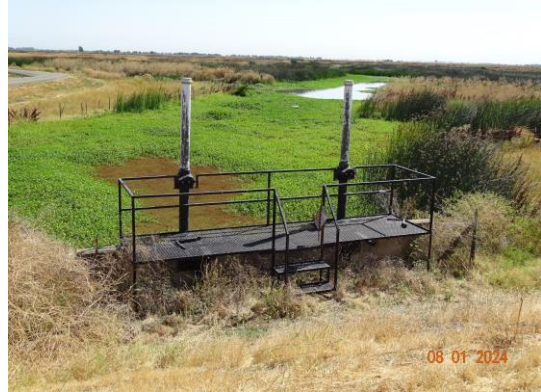
View of manual gate controls. (2024)

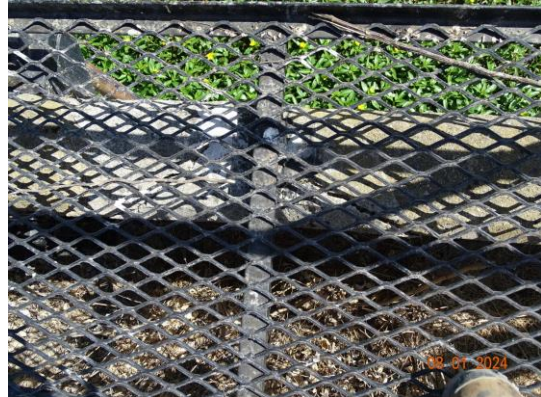
Small cracking on the headwall. (2024)

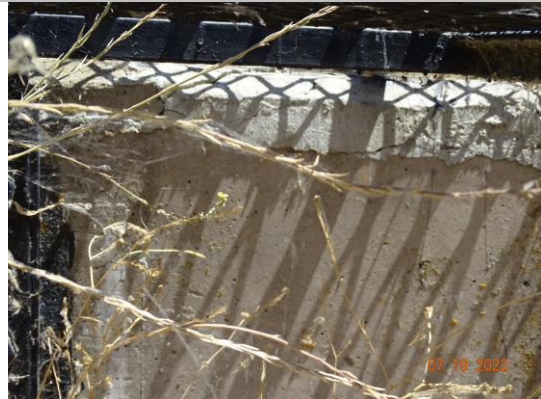
Another view of the cracking on the headwall. (2022)

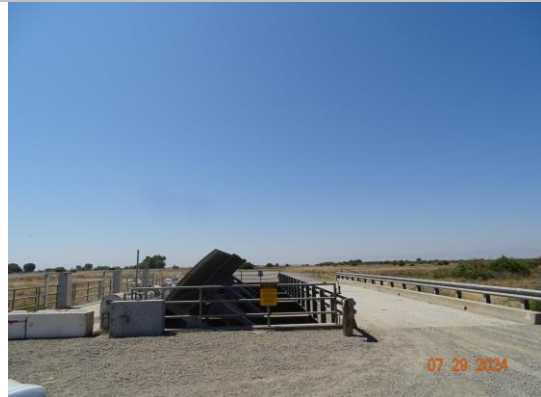
View of top of the structure from right bank. (2024)

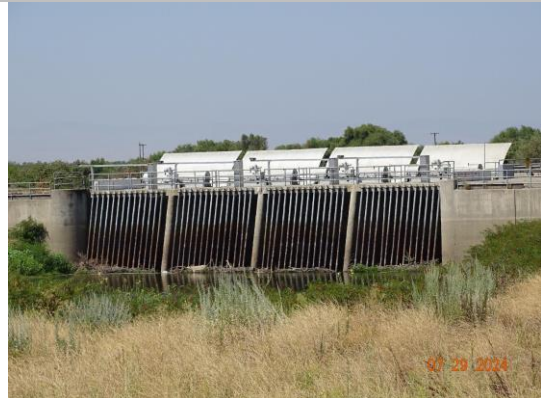
View of trash racks. (2024)

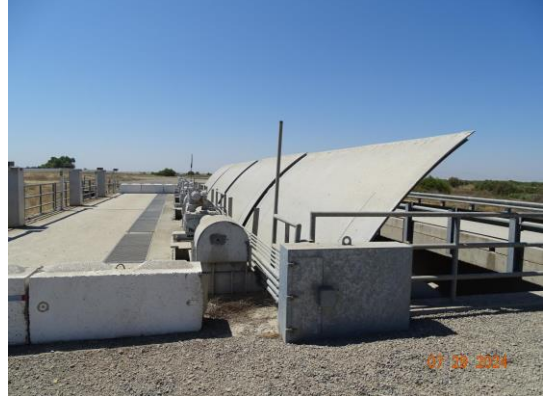
View of the radial gates. (2024)

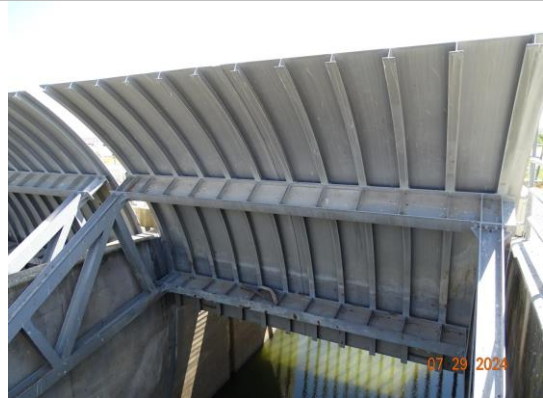
Typical view of the radial gates. (2024)

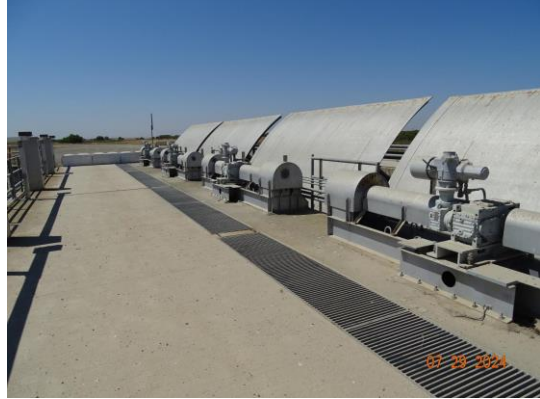
View of the electric gate operators. (2024)

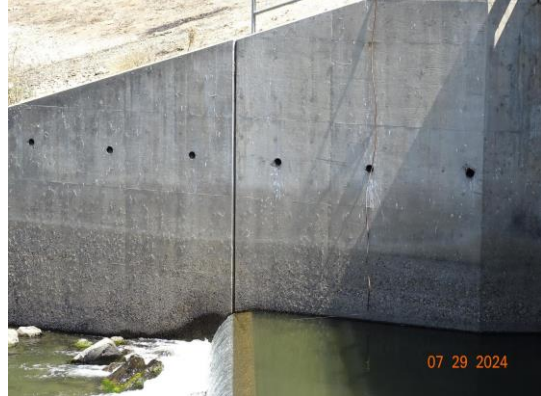
Felt in monolith joint on right wing wall has deteriorated. (2024)

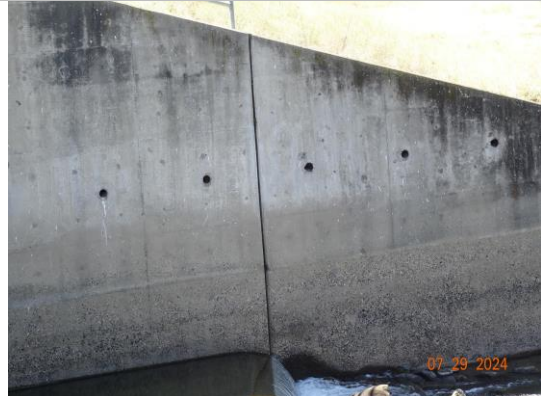
Felt in monolith joint on left wing wall has deteriorated. (2024)

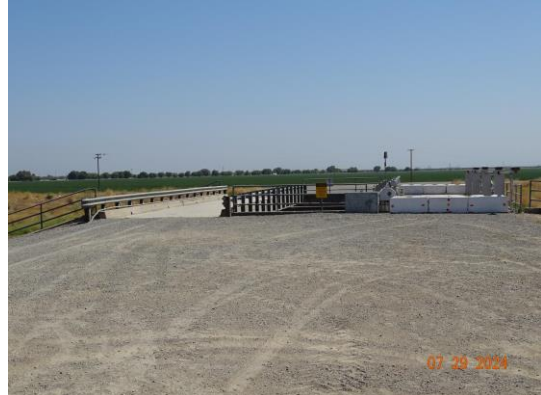
View of the top of the structure. (2024)

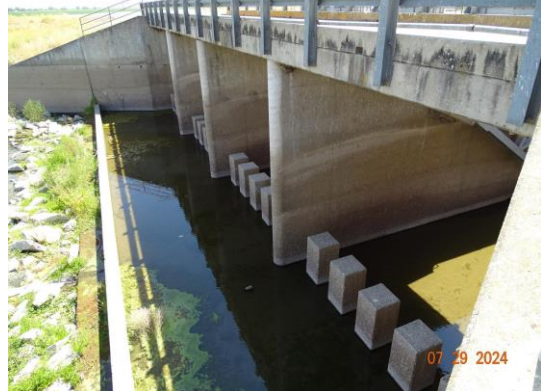
View of the structure outlets. (2024)

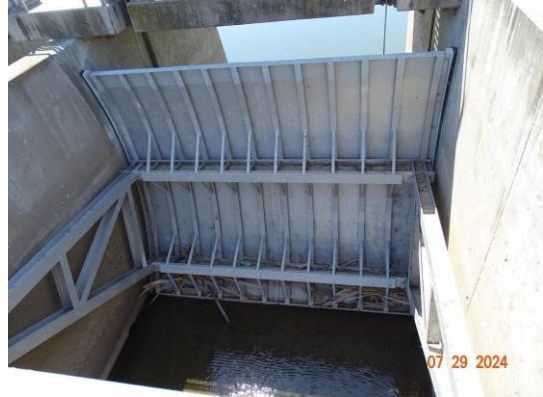
Typical view of the structure bays. (2024)

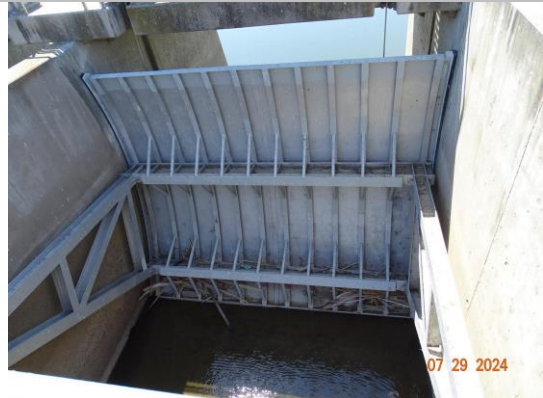
Representative picture of the gates. (2024)

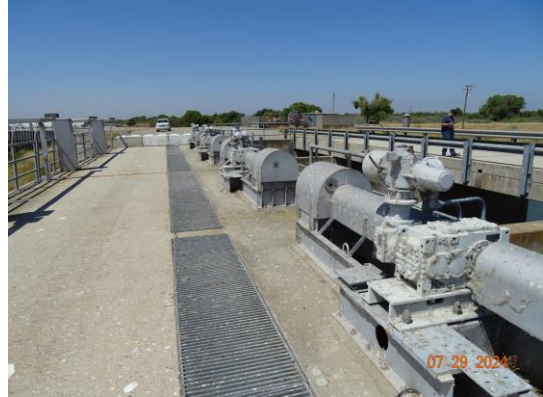
View of electric gate operators. (2024)

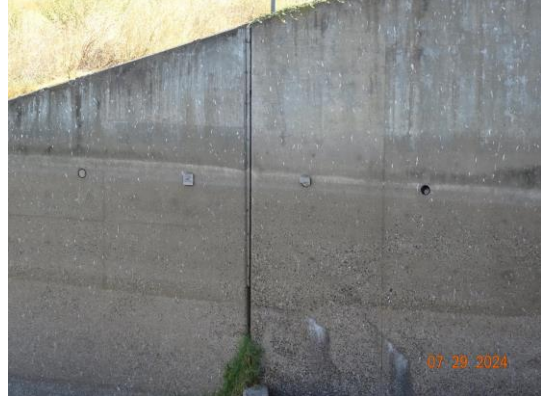
Monolith joint deterioration on the right downstream wing wall. (2024)

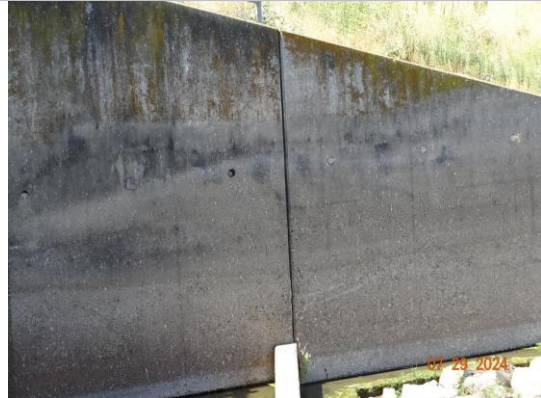
Deterioration of the left downstream wing wall joint. (2024)

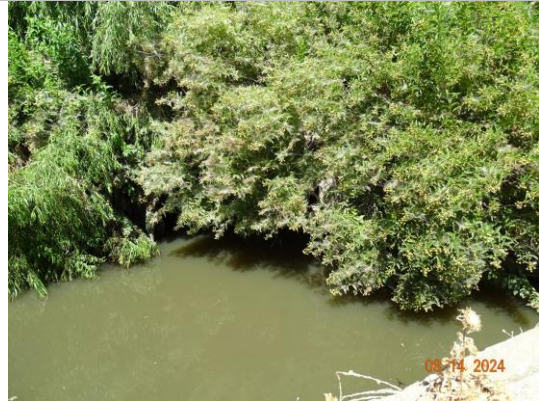
Trees growing over the downstream side of the structure. (2024)

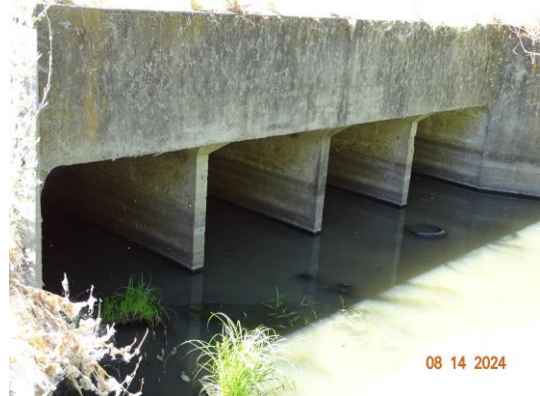
View of culvert outlet. (2024)

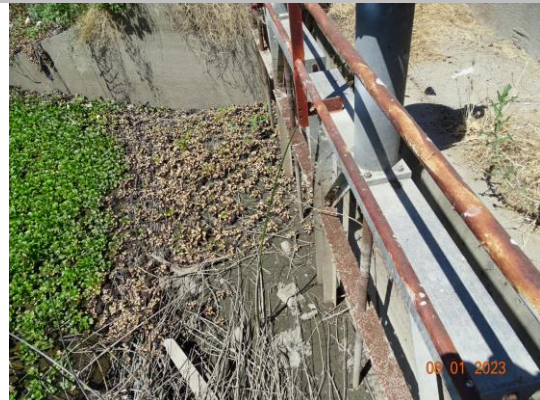
Sedimentation built up above slide gate. (2023)

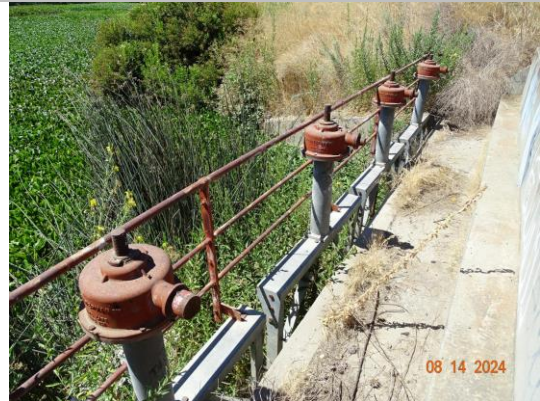
View of the manual gate operators. (2024)
