## Levee Inspection Report By Mile - Structure 2024

**\*\*\* Preliminary Data \*\*\***

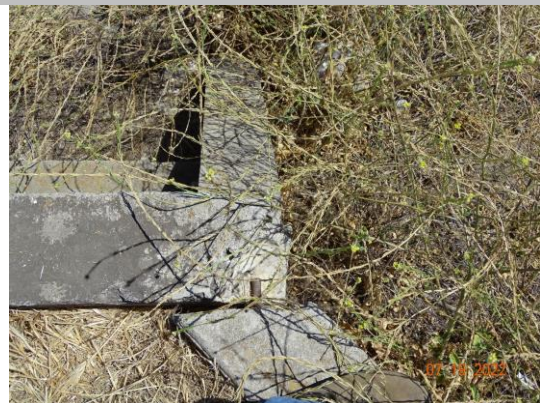
View of cracking at the joint on the left inlet side. (2022)

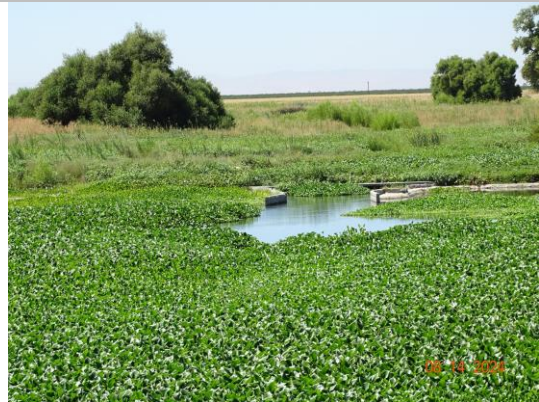
View of the downstream side of the structure. (2024)

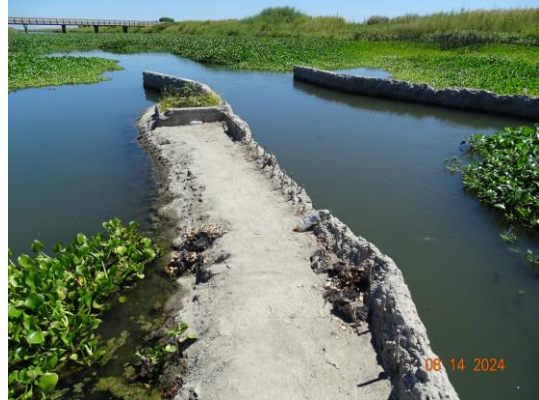
Damage to the left wall of the structure. (2024)

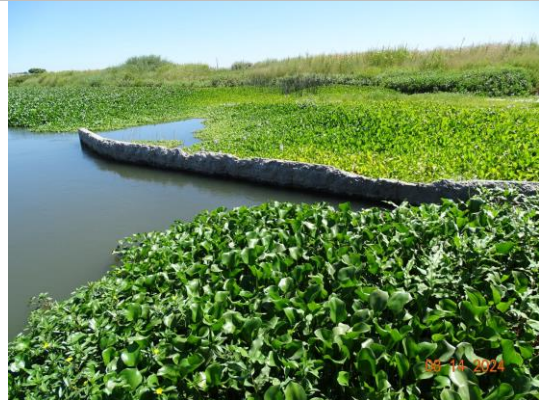
Damage to the right wall of the structure. (2024)

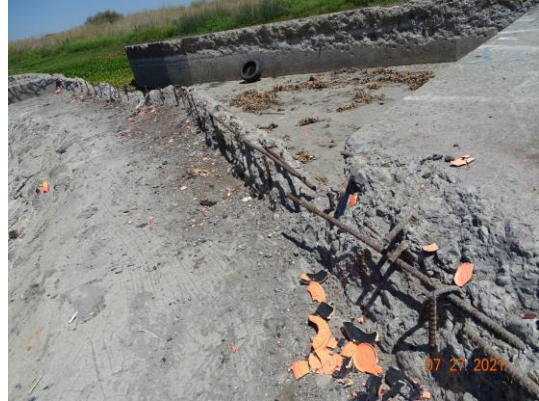
Damage to left wall of structure. (2021)
