Lower San Joaquin River Flood Control Project System Assessment

Regional Flood Management Planning

LOWER SAN JOAQUIN
LEVEE DISTRICT

Executive Summary

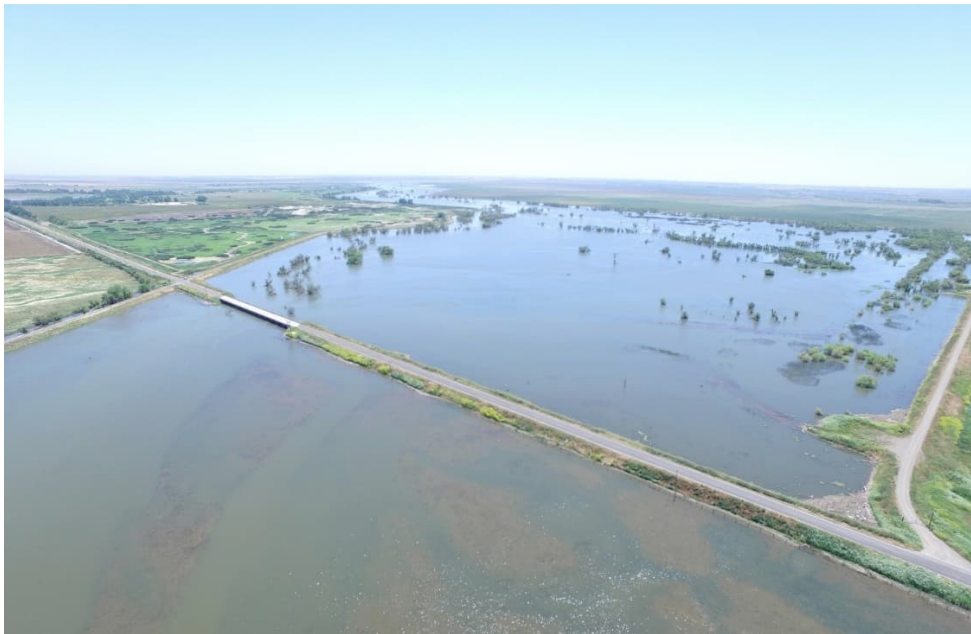
Figure 5-13. Sandy Mush Road Close to Overtopping at 10,000 cfs

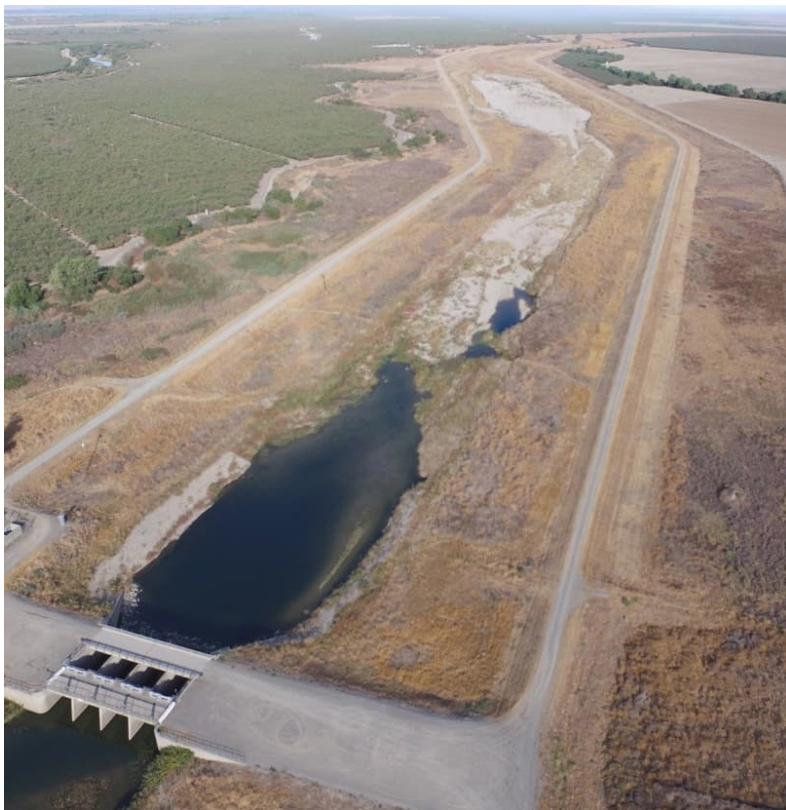
Figure 5-18. Sedimentation in Chowchilla Bypass Downstream of the Chowchilla Canal Bypass Control Structure

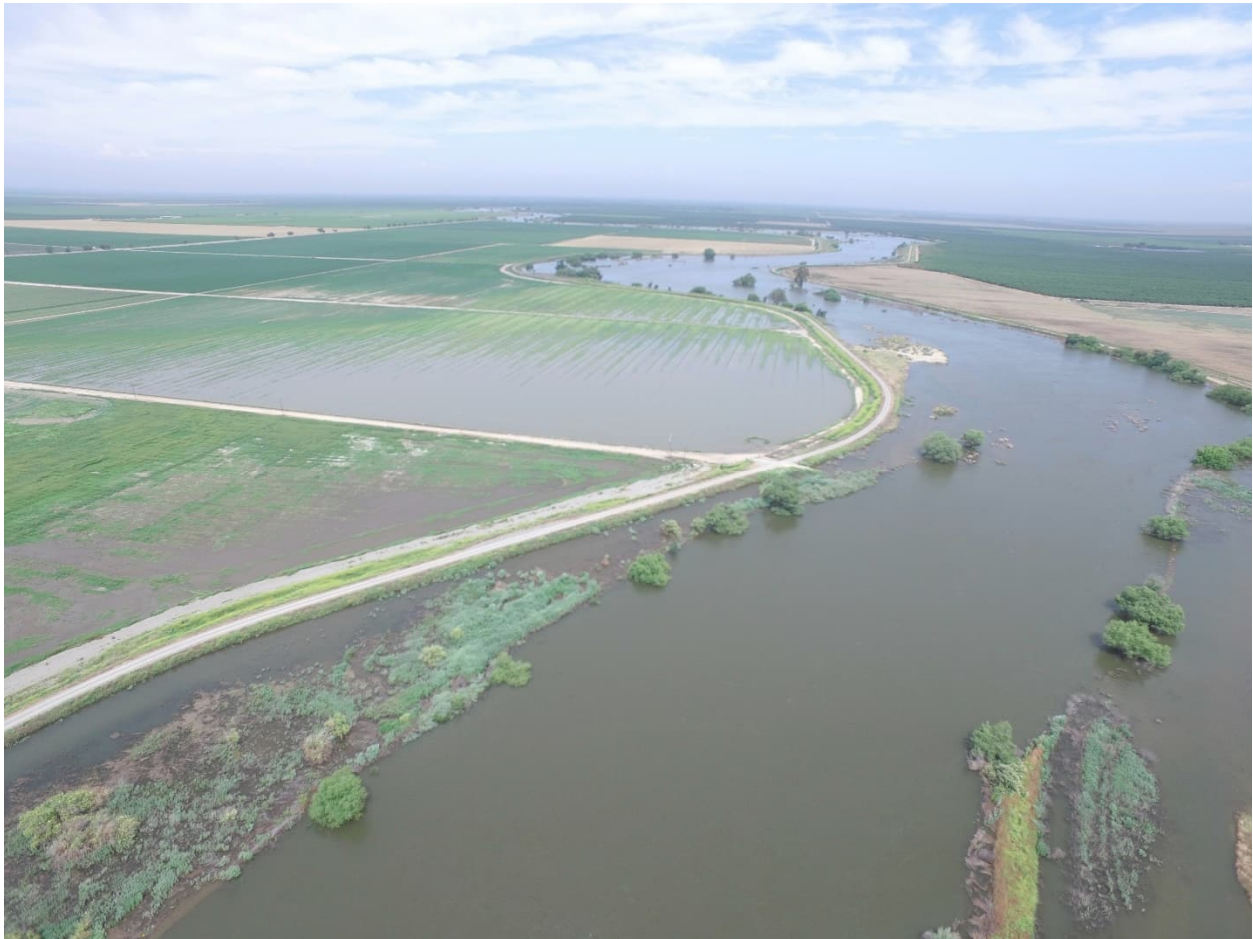
Figure 5-19. Seepage from San Joaquin River Upstream of Chowchilla Canal Bypass Control Structure–10,000 cfs

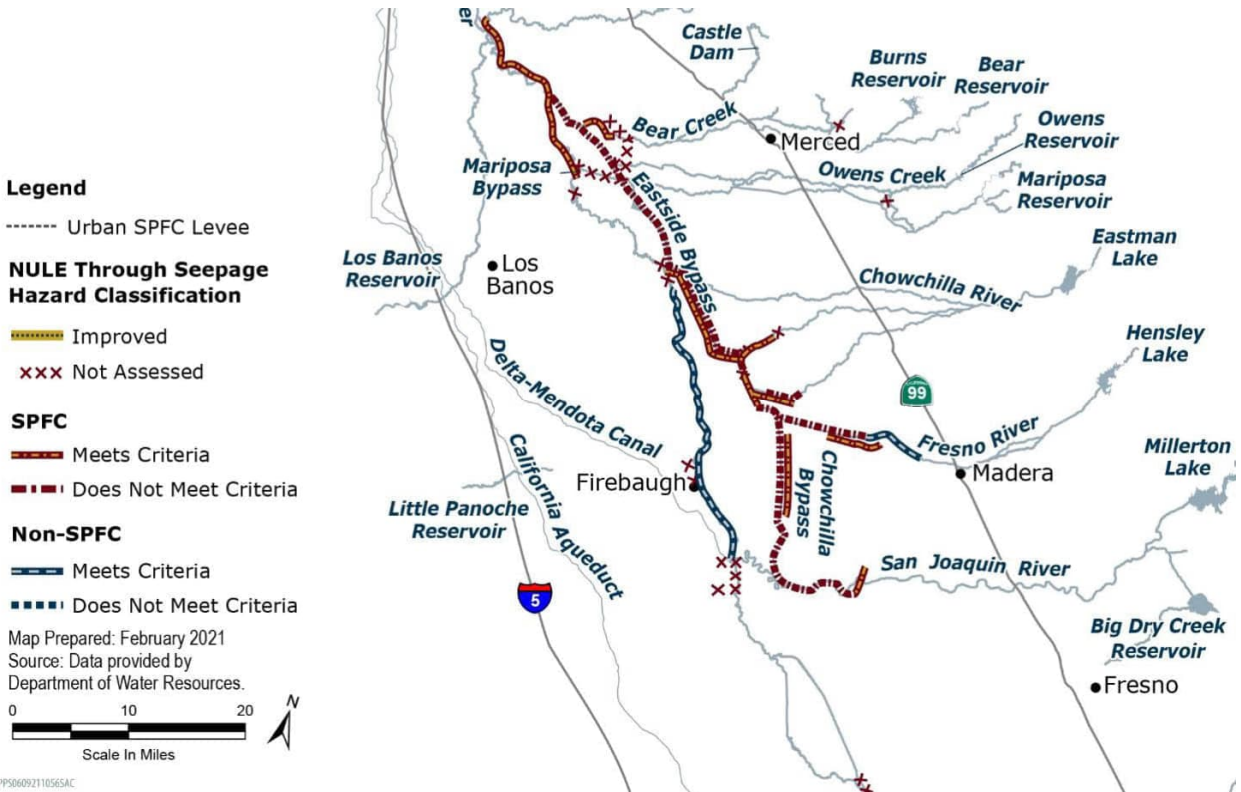
Through-seepage occurs when water moves from a waterway through a levee. When water moving through or under a levee carries foundation soil or levee materials, piping action may result in settlement or erosion of a levee's landside toe or slope. This may cause a levee to breach during high-water events. Figure 5-20 shows the 2022 FSSR NULE Project through-seepage ratings where "Does Not Meet Criteria" is considered hazardous, as well as potential for levee failure. Table C-1 (Appendix C) summarizes this information and shows that most of the levee system along Chowchilla Bypass and the Eastside Bypass does not meet criteria.

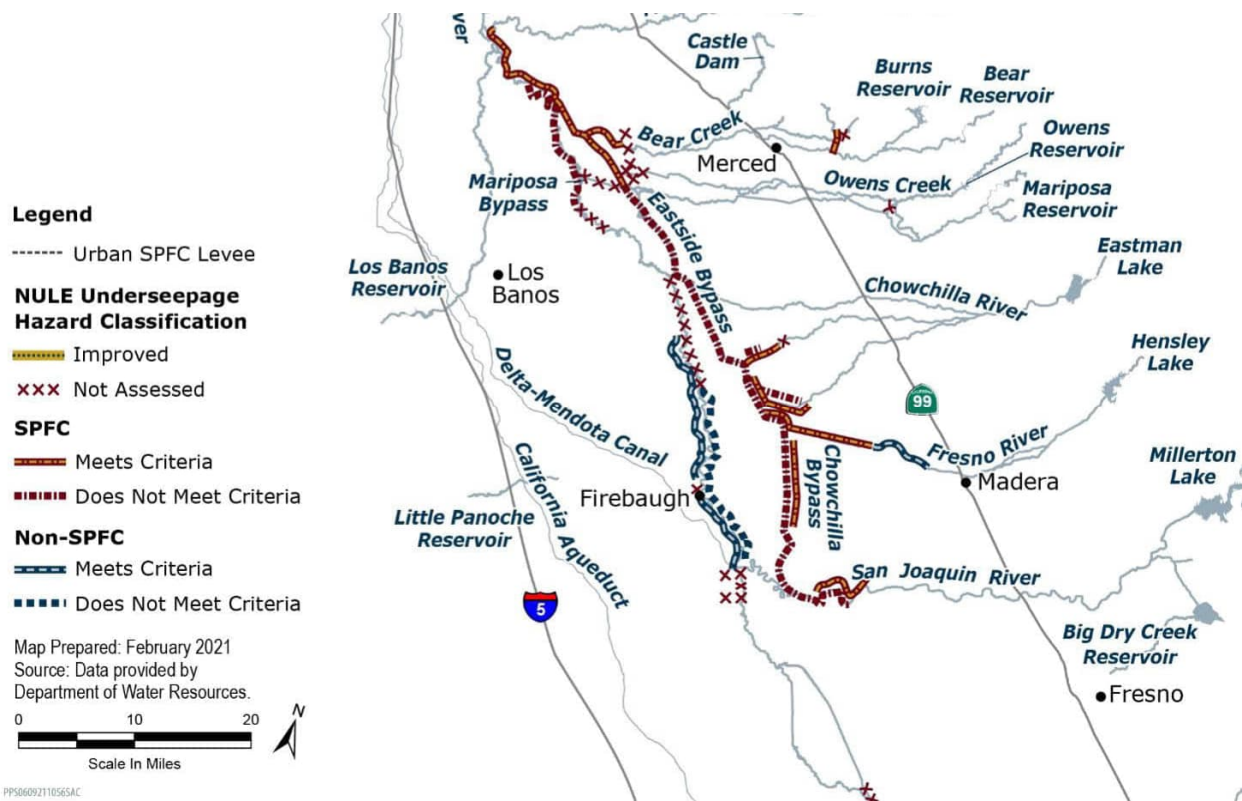
Under-seepage occurs when permeable foundation material or native soils beneath the base of a levee present a pathway for water to move under a levee and exit at the surface near or beyond the landside levee toe. Figure 5-21 shows 2022 FSSR NULE Project under-seepage ratings where “Does Not Meet Criteria” is considered hazardous, as well as potential for levee failure. Table C-1 (Appendix C) summarizes this information. Most of the levees along Chowchilla Bypass and the Eastside Bypass do not meet criteria.

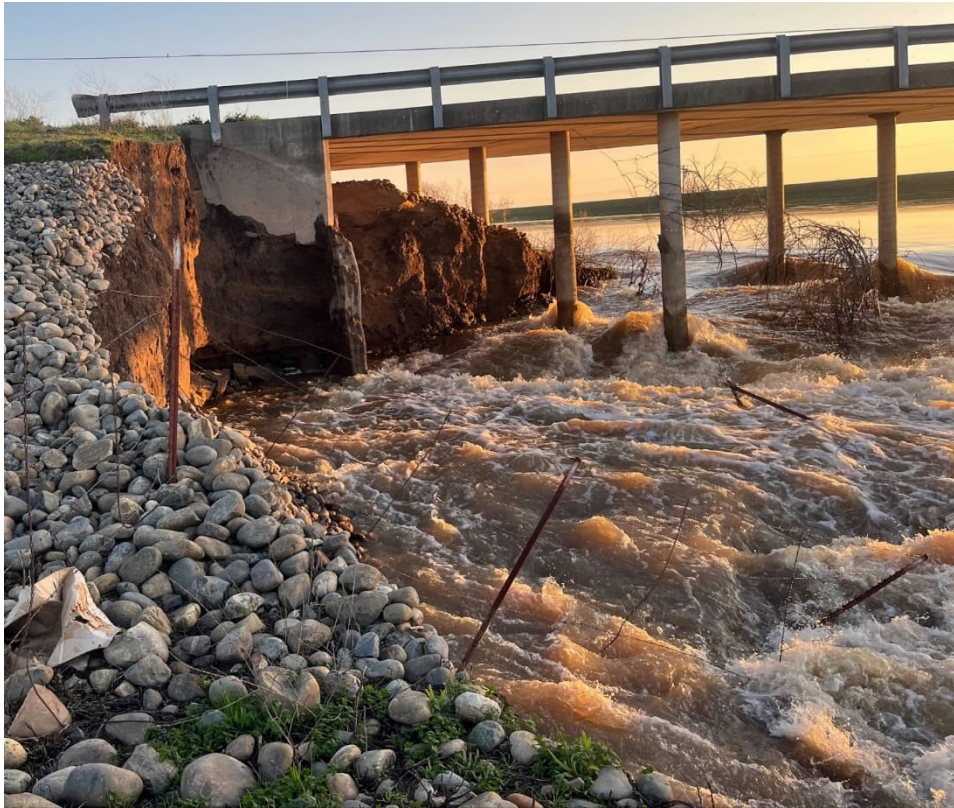
Figure 5-23. Avenue 18 1/2 Bank Erosion

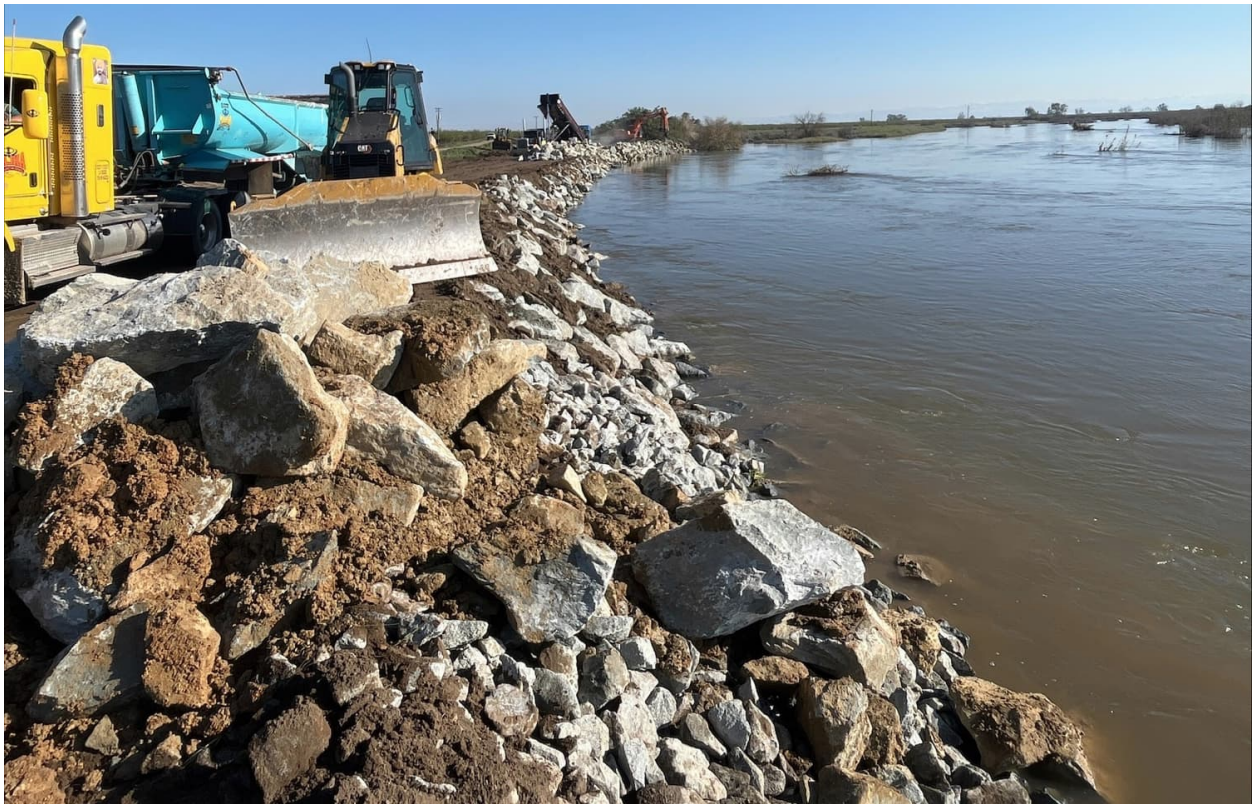
The 2015 USJR RFMP (SJRFCA 2015) identified that the District needs additional financial resources to secure temporary construction easements to repair and stabilize levee erosion sites. At the end of the 2023 winter storm season, in March 2023, LU 23 received emergency repairs for extensive erosion (Figure 5-25).

Figure 5-25. Emergency Erosion Repair - March 2023
