Lower San Joaquin River Flood Control Project System Assessment

Regional Flood Management Planning

LOWER SAN JOAQUIN
LEVEE DISTRICT

Executive Summary

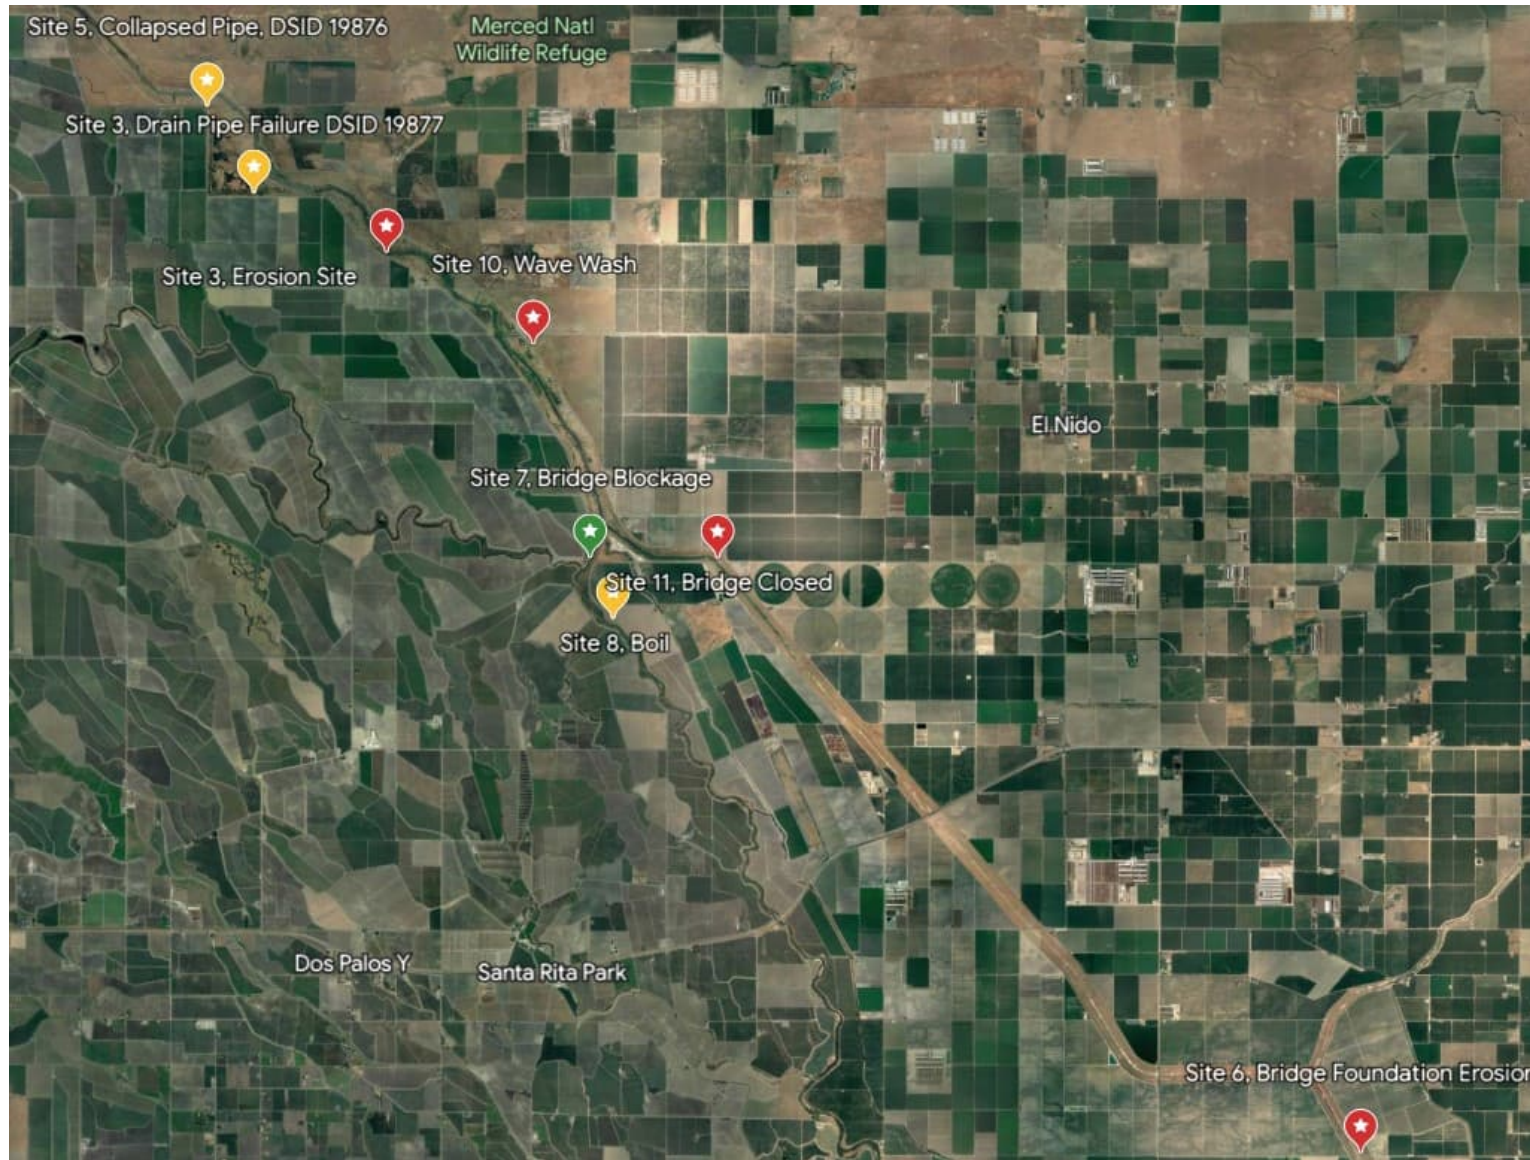
Figure 4-1. 2023 Water Year Issues—North Portion of the Project

Figures 4-1 and 4-2 show locations of documented issues for the north and south portions of the system, respectively.

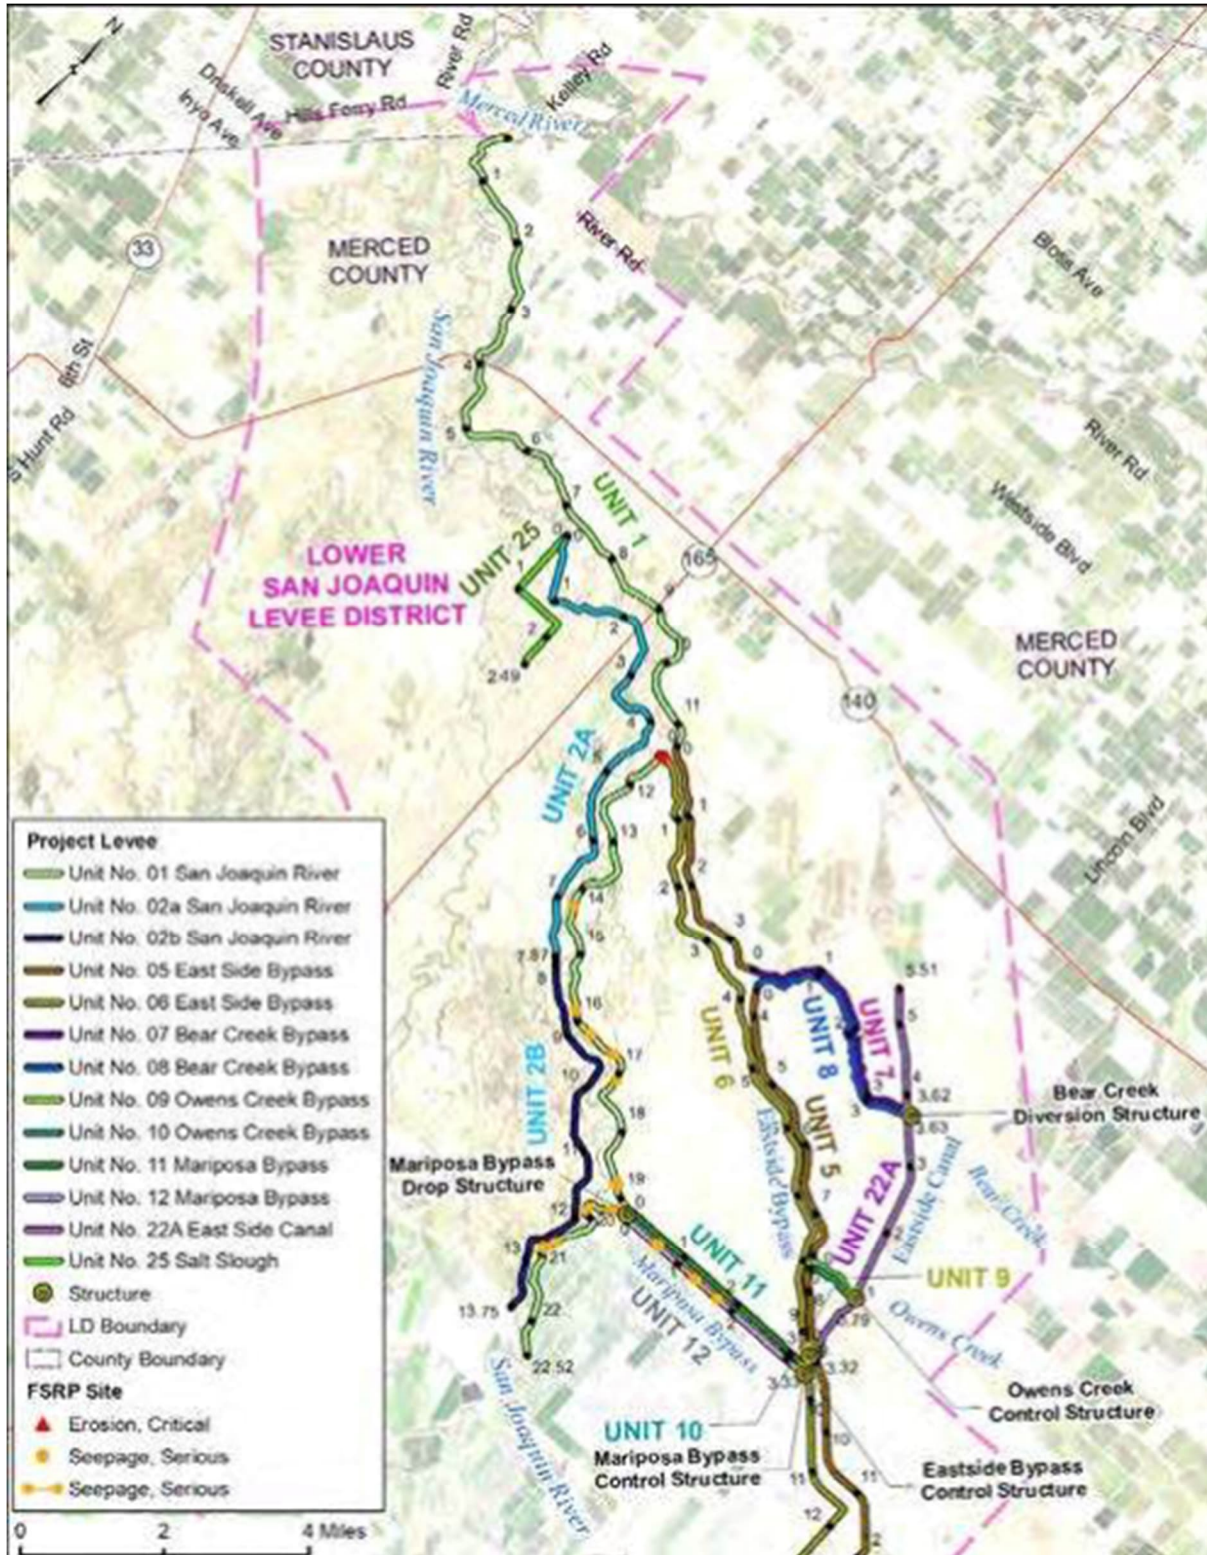
Figure 4-3. DWR Flood System Repair Program Erosion and Seepage Sites—North Portion of the Project

Maps of the District levees with erosion and seepage sites identified as part of the FSRP are shown on Figure 4-3 through Figure 4-5. These sites are tabulated in Appendix A. DWR gives a summary of unacceptable erosion sections in the District, as summarized in Section 5.2.8. The Fall 2023 DWR Inspection Report (DWR 2023) was released shortly before the release of this assessment. The only difference between the Fall 2023 and Fall 2022 DWR Inspection Reports (DWR 2023, 2022c) is an acceptable rating in the 2023 report for Ash Slough Drop Structure 3. However, the District would like to pursue further condition evaluation of this structure.

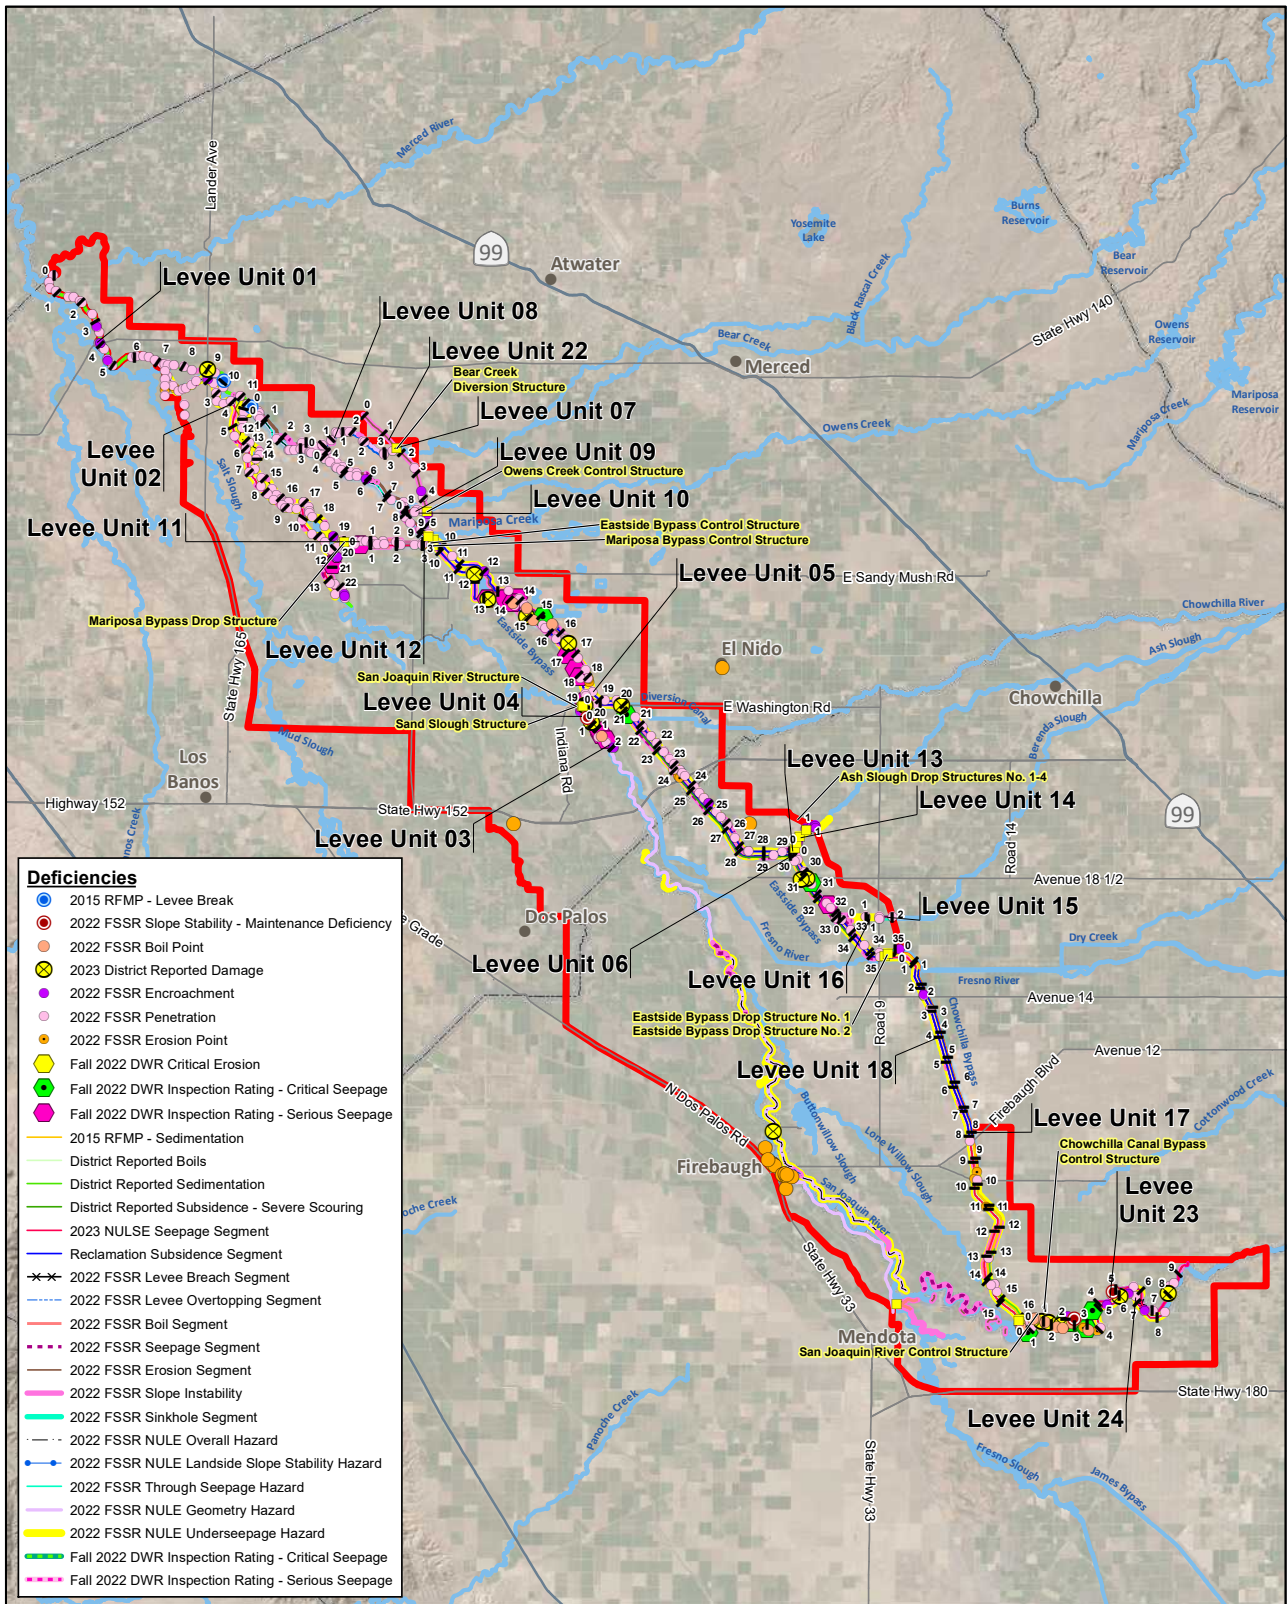
FIGURE 5-2
All Levee Unit Deficiencies with River Miles
 Regional Flood Management Plan
Lower San Joaquin Levee District System Assessment and Recommendations

This chapter synthesizes data from Chapter 4 into a concise summary of District flood management issues. Figure 5-1 shows the overall District boundary with LU mileage, District facilities, and essential facilities (such as schools and hospitals). Figure 5-2 shows the same basemap overlaid with all levee integrity issues. Because there are numerous deficiencies that overlap, Figures 5-3 through 5-11 show more focused maps organized by LU group so the viewer may better differentiate between levee integrity issues. Appendix B documents symbols or linework that may be difficult to perceive on the detailed maps and tabulates all data from Chapter 4.

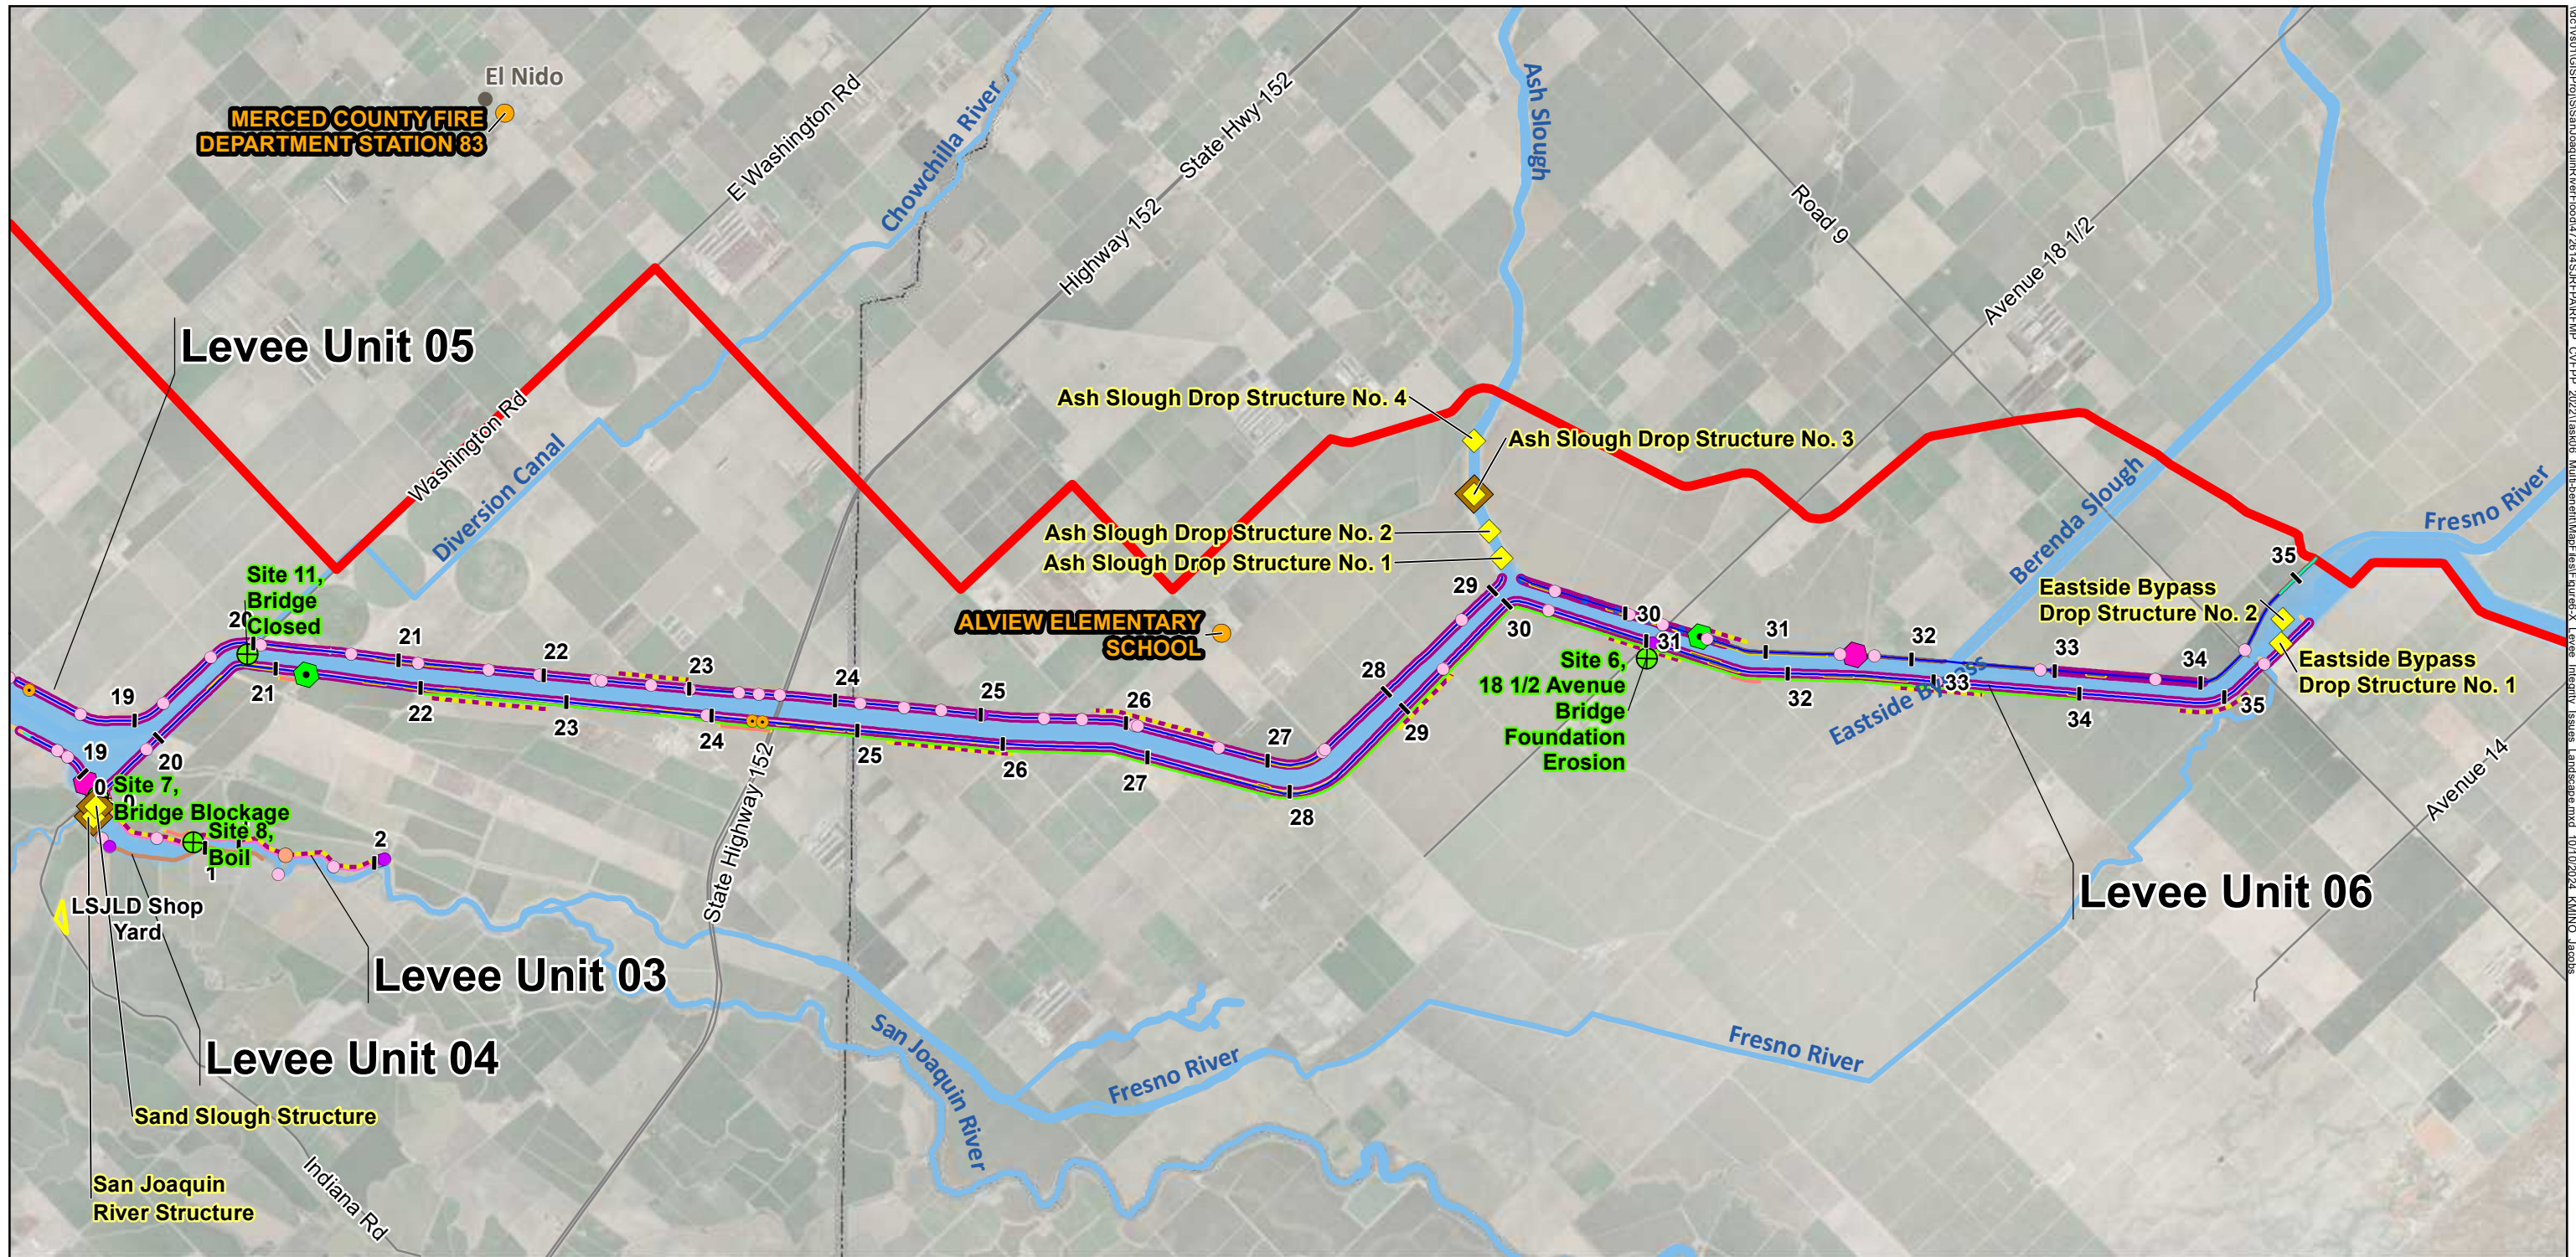
*District reported that subsidence is so deep in this area that large flood water will not hit the toe of levee

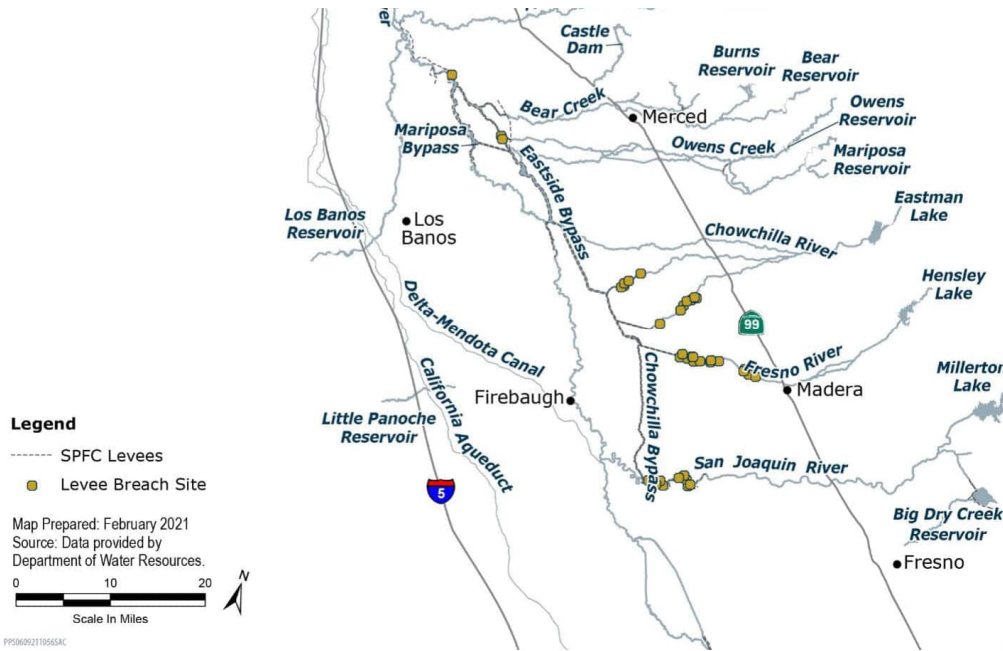
Figure 5-14. Historical Breach Sites

The 2015 USJR RFMP (SJRF CPA 2015) identified that Project levees breached at LU 1 (RM 9.90) and at LU 5 (RM 0.25). USACE inspections rated these LUs as unacceptable and suggested installing new structures to allow the Project to operate as intended. The 2022 FSSR (DWR 2022b) shows historical breach sites (Figure 5-14). The FSSR NULE overall hazard classifications, described in Section 5.2.13, can be helpful in identifying potential breach sites.

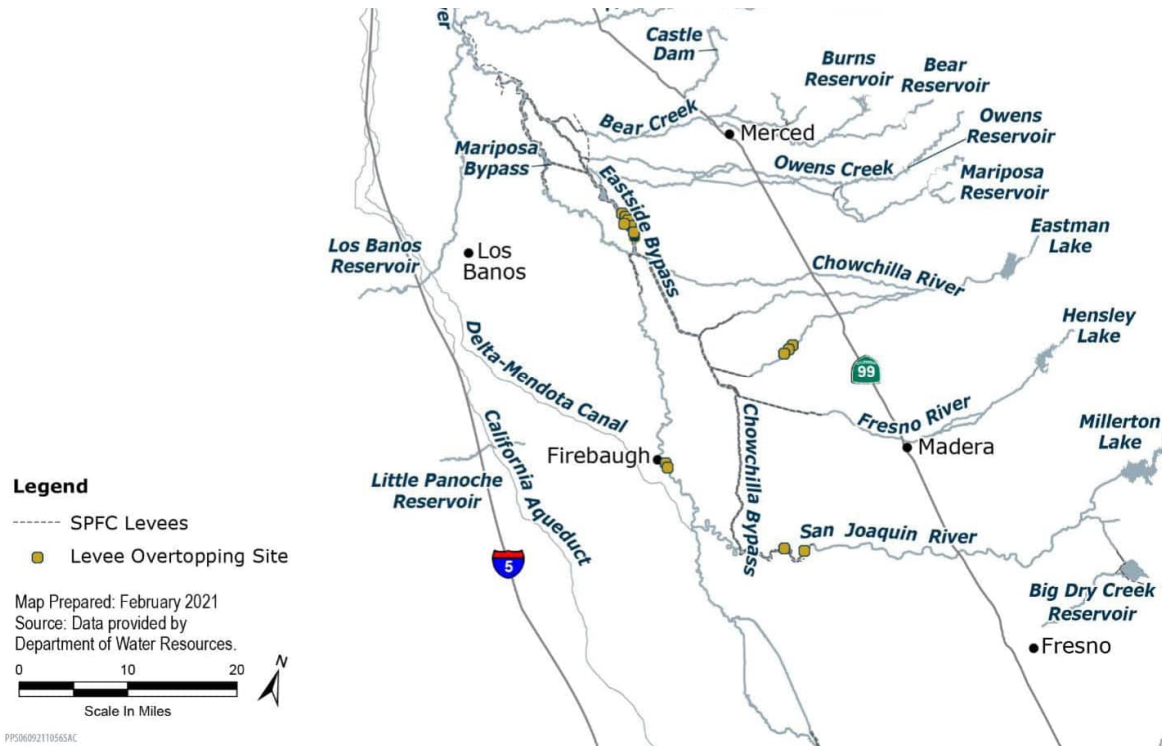
Figure 5-15. Historical Levee Overtopping

Overtopping occurs when water in a channel exceeds flow capacity and water flows over the levee, flooding adjacent land. Figure 5-15 shows historical levee overtopping sites from the 2022 FSSR (DWR 2022b).

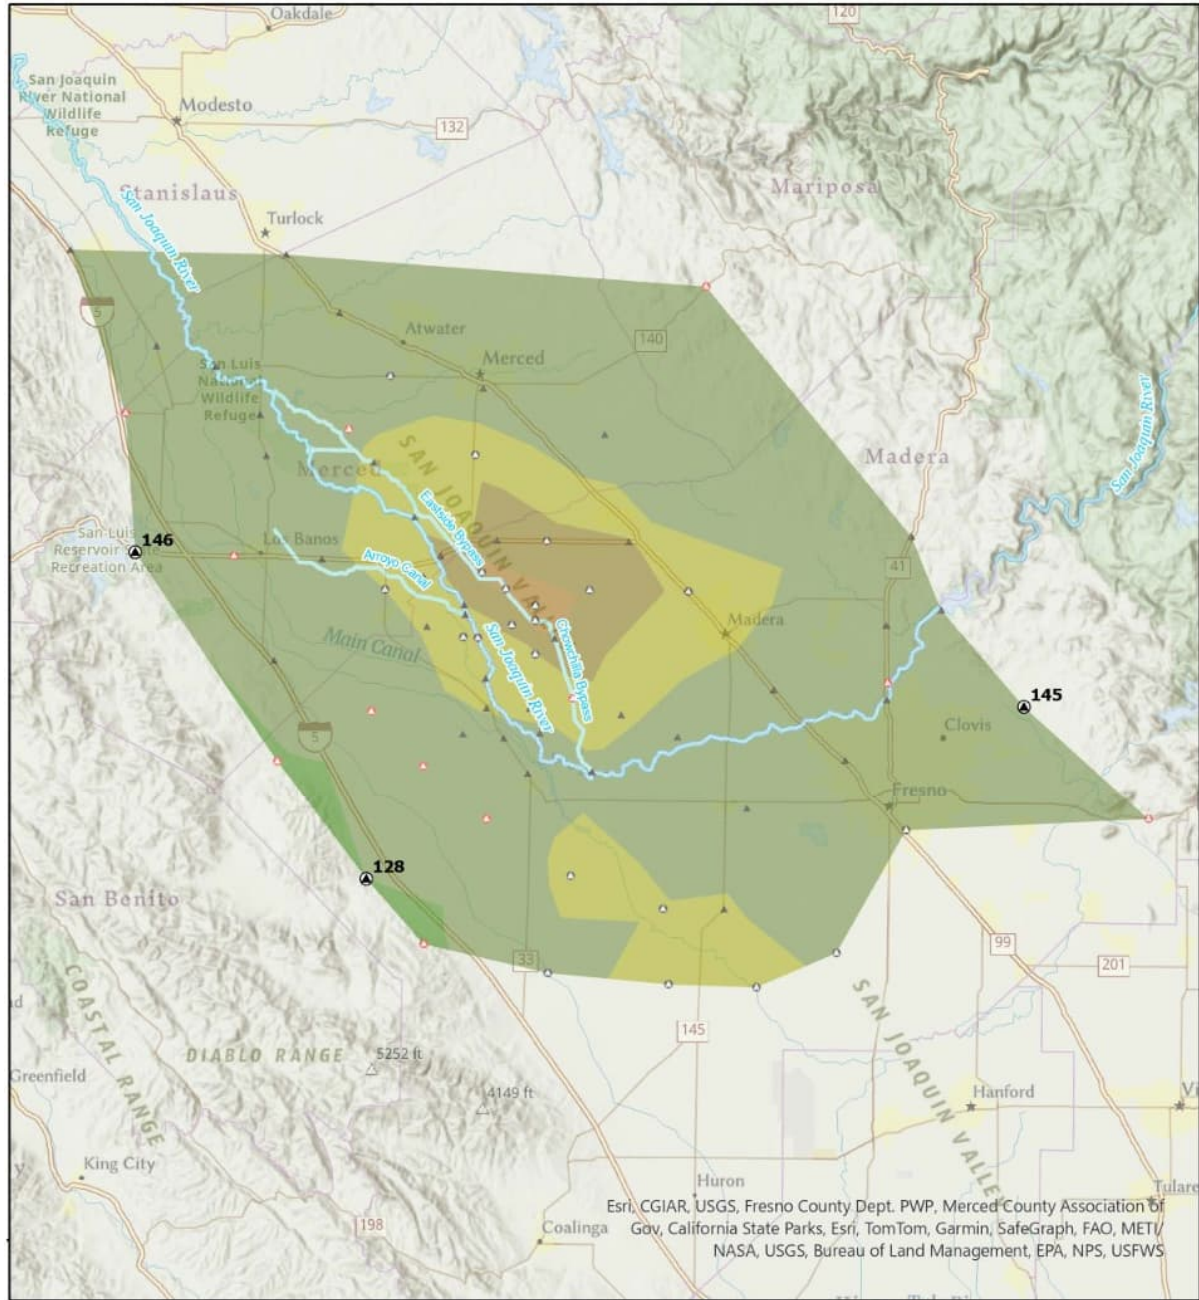
Figure 5-16. Subsidence Rates in the District – July 2012 to July 2025

For the District, subsidence is a significant issue along the Chowchilla Bypass to the Eastside Bypass from Avenue 7 in Merced County up to Washington Avenue in Merced County, and along the Eastside Bypass from the Washington Avenue area northward to the Mariposa Bypass. The USBR subsidence map, shown on Figure 5-16, shows historical subsidence rates for July 2012 to July 2025. The highest subsidence rates occur in the Chowchilla Canal Bypass and Eastside Bypass, ranging from -0.6 to -0.45 foot/year. Figure 5-17 shows subsidence from July 2024 to July 2025, demonstrating that the highest subsidence rates still occur in the Chowchilla Canal Bypass and Eastside Bypass, with rates ranging from -0.6 to -0.45 foot/year. Subsidence may increase channel gradients that increase flow velocities and cause channel deepening due to erosion of the channel bed. Subsidence may also decrease channel gradients, thereby

reducing flow velocities, causing suspended sediment to settle out, and ultimately resulting in sediment buildup and reduced flow capacity. Subsidence also reduces the ground level and levee elevation, making the system more susceptible to overtopping at low points that have reduced freeboard capacity.

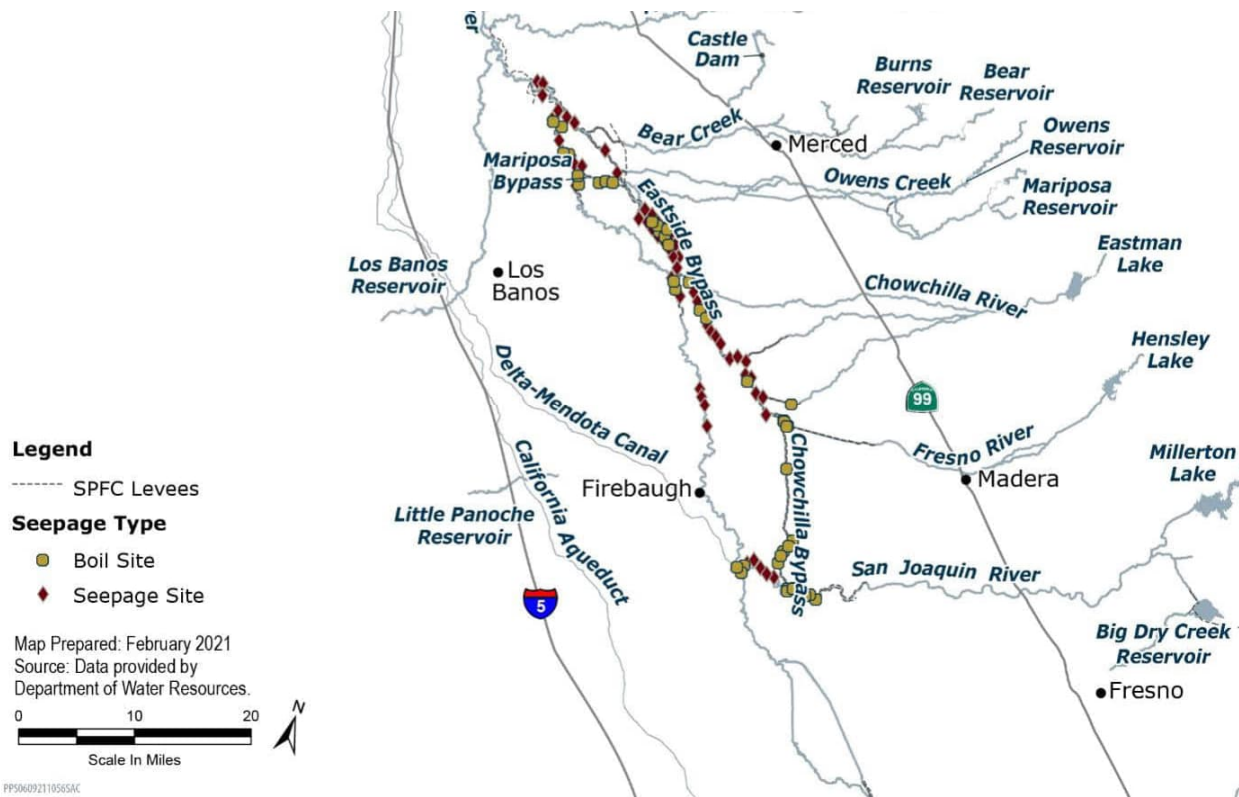
Figure 5-22. Historical Boil and Seepage Sites

Boils are an upward disturbance in a small, permeable section of an otherwise relatively impermeable surface layer. In the 2023 water year, the District reported four boil sites. Figure 5-22 shows the 2022 FSSR historical boil and seepage sites (DWR 2022b).

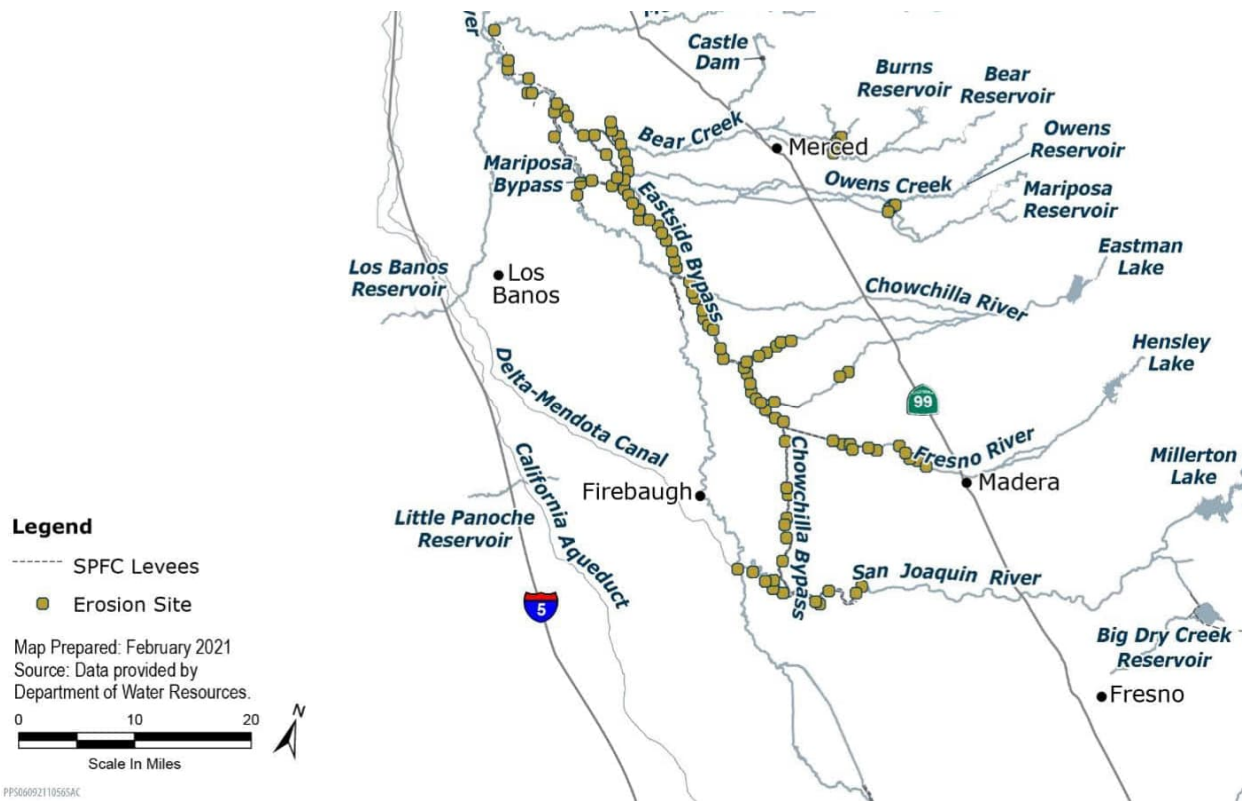
Figure 5-24. Historical Erosion Sites

The Fall 2022 DWR Inspection Report (DWR 2022c) documented erosion failures. Maps of critical erosion sites are shown on Figures 4-3 through 4-5. Table 5-2 summarizes unacceptable erosion sections on the San Joaquin River. Additionally, the Fall 2022 DWR Inspection Report identified critical erosion at LU 6. The 2022 FSSR (DWR 2022b) identifies historical erosion sites, as shown on Figure 5-24.

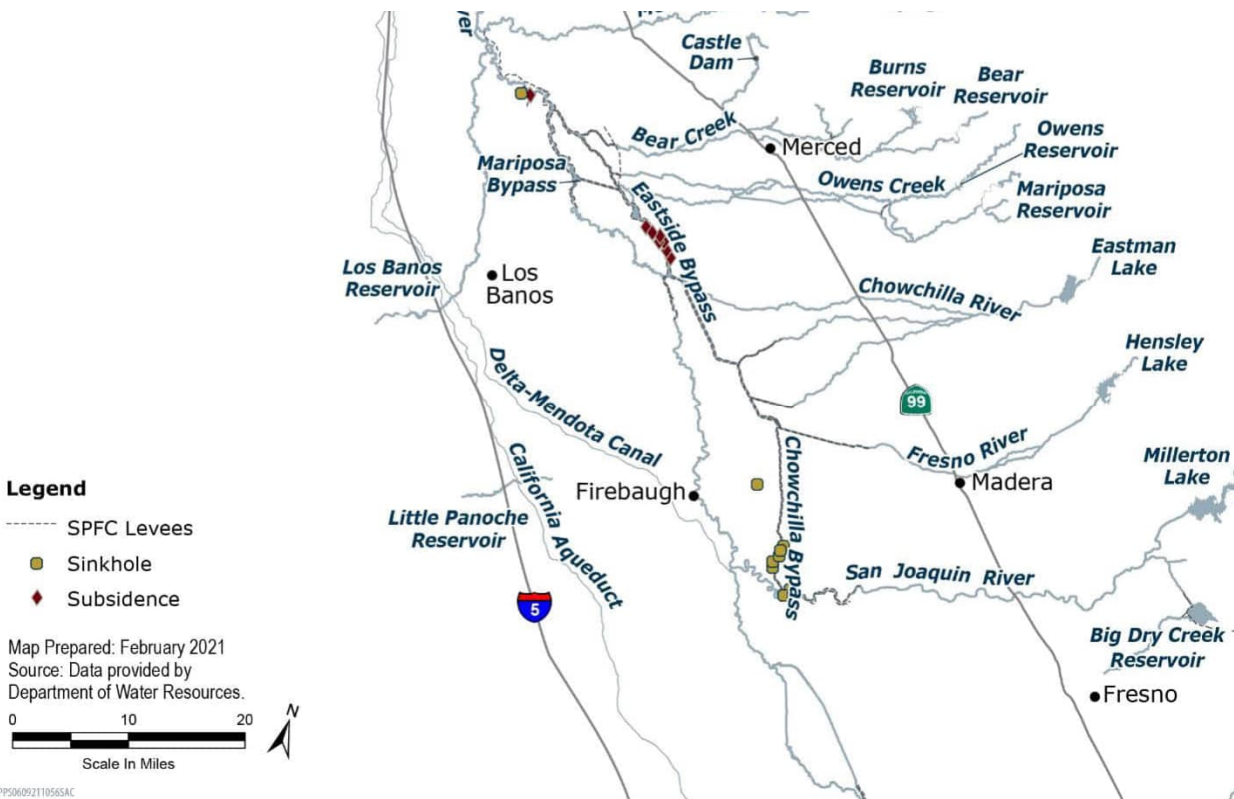
Figure 5-26. Historical Sinkholes and Subsidence Distresses

A sinkhole is a cavity in the ground caused initially by water erosion, and later by a drop in the groundwater table. During the 2023 water year, the District reported one sinkhole site. Figure 5-26 shows the locations of historical sinkholes and subsidence distresses as documented in the 2022 FSSR (DWR 2022b).

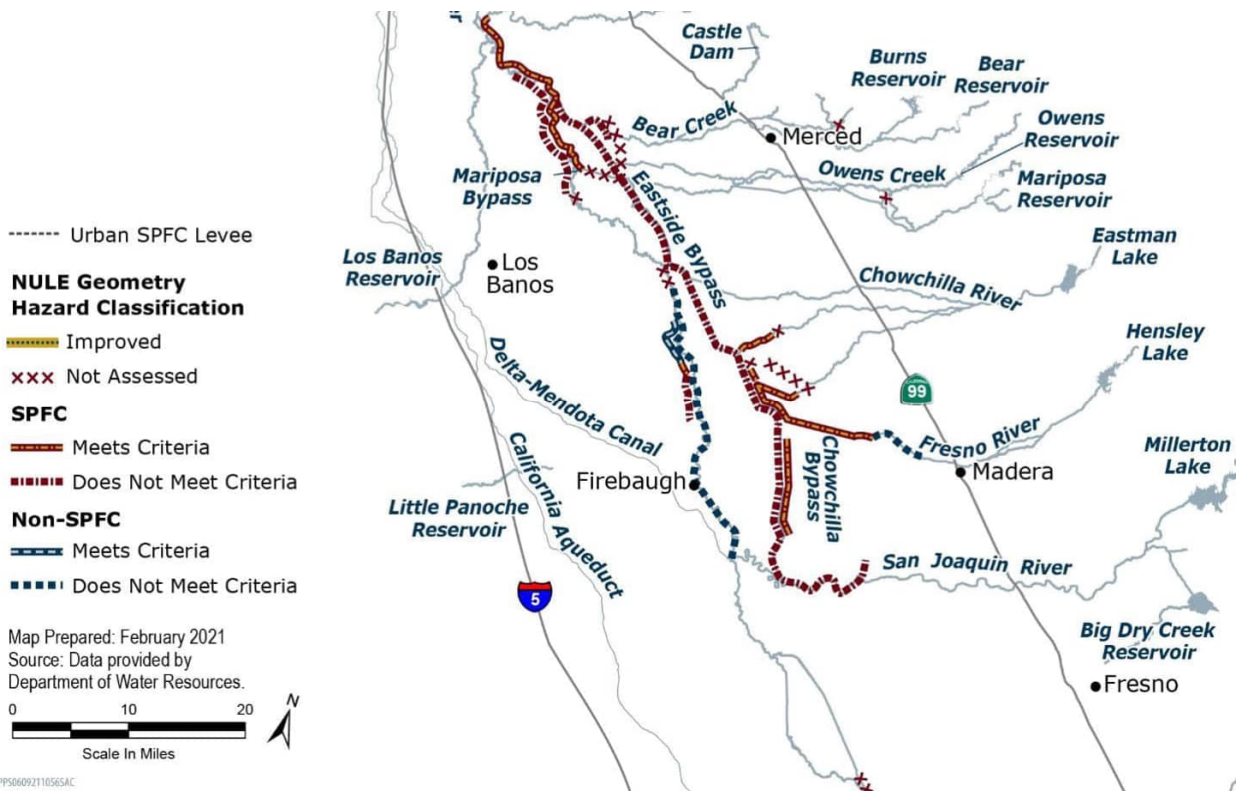
Figure 5-27. Non-Urban Levee Evaluation Project Levee Geometry Checks in the District Area

Results from the 2022 FSSR (DWR 2022b) evaluation are shown on Figure 5-27 and are summarized in Table C-1 (Appendix C) in the geometry column. “Does Not Meet Criteria” is considered hazardous and shows the potential for levee failure.

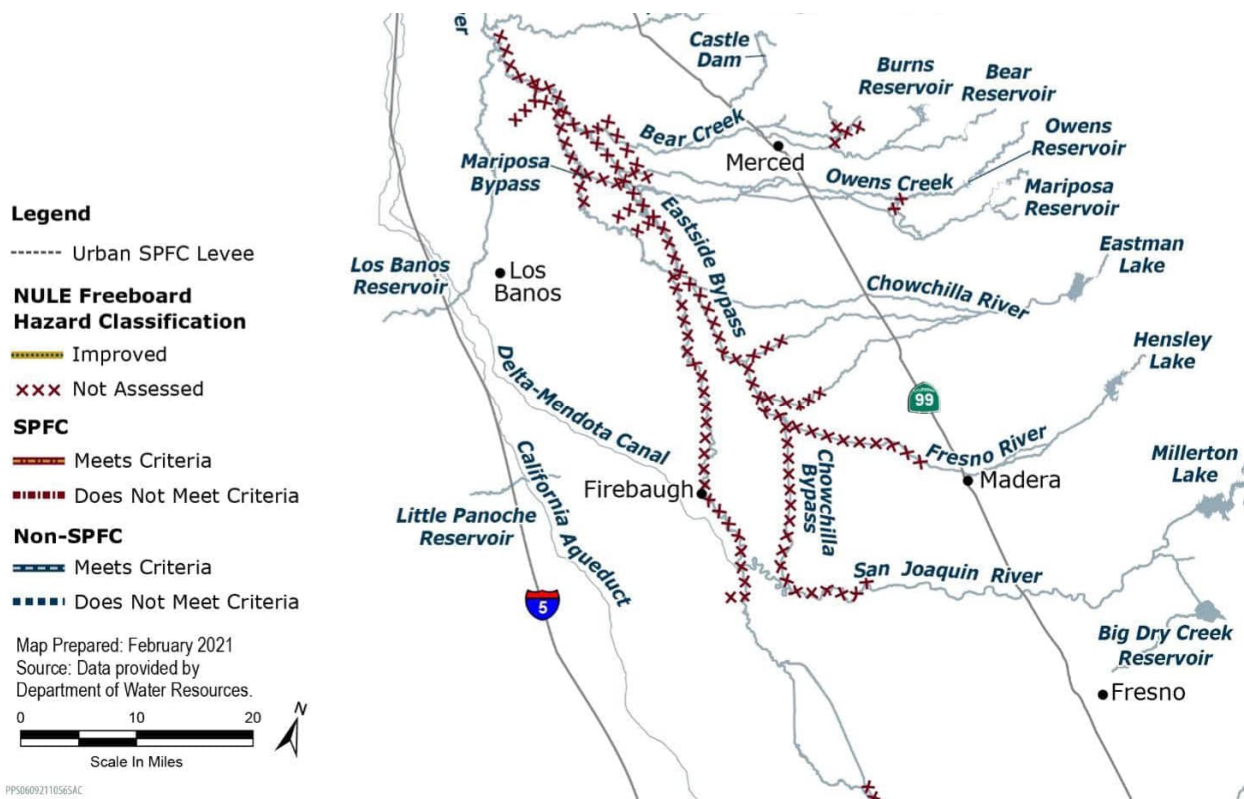
Figure 5-28. Non-Urban Levee Evaluation Project Freeboard Check Results

The criteria are 3 feet of freeboard above design water surface elevation for riverine levees and 4 feet of freeboard for bypass levees. Results for the 2022 FSSR evaluation (DWR 2022b) are shown on Figure 5-28 and are summarized in Table C-1 (Appendix C) in the freeboard column. “Does Not Meet Criteria” means less than 3 feet of freeboard for riverine levees and less than 4 feet of freeboard for bypass levees.

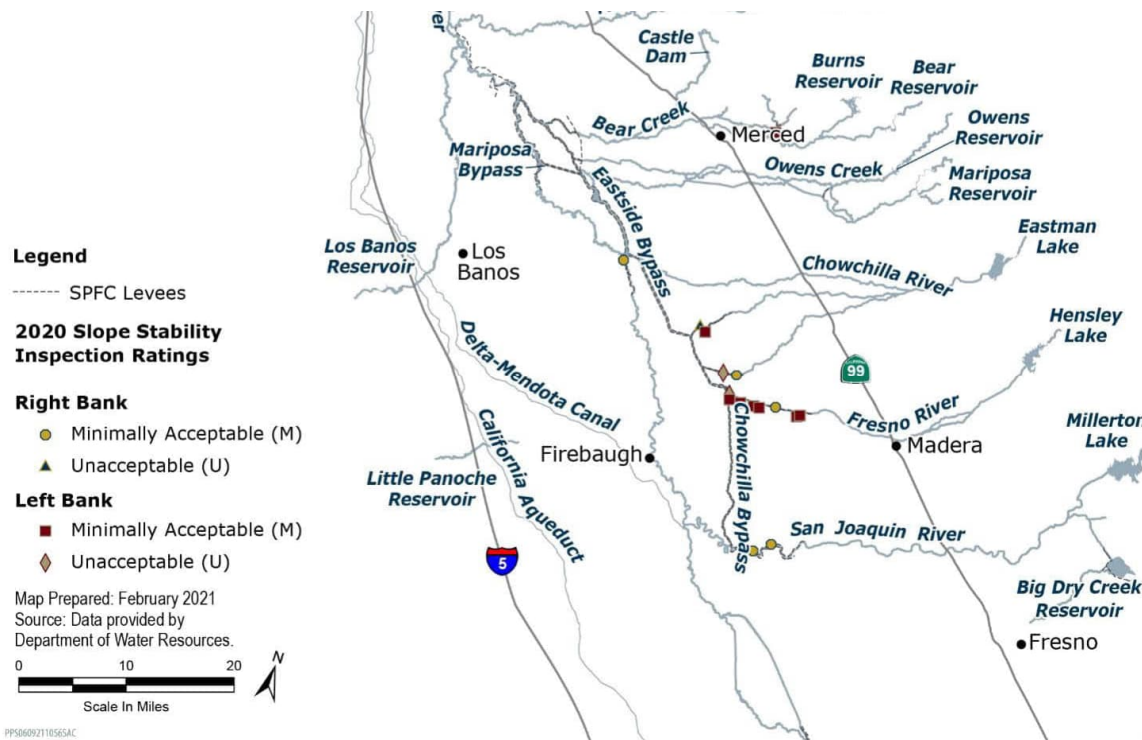
Figure 5-29. Slope Stability Inspection Rating Results

Levee structural instability is characterized by slides, sloughs, cracking, slope depressions, or bulges that could pose a threat to levee integrity. Structural instability is often associated with soft soils in a levee or its foundation, or with older design and construction practices. New stability analyses may be necessary on existing levees, particularly on older levees constructed before adoption of current criteria. Table 5-3 lists DWR inspection ratings. Areas with the most slope instability are in the San Joaquin River upstream of the Chowchilla Canal Bypass Control Structure and the Chowchilla Bypass near the Fresno River. There is also a minimally acceptable rating on the Eastside Bypass and San Joaquin River interchange. Figure 5-29 shows slope stability inspection rating results.

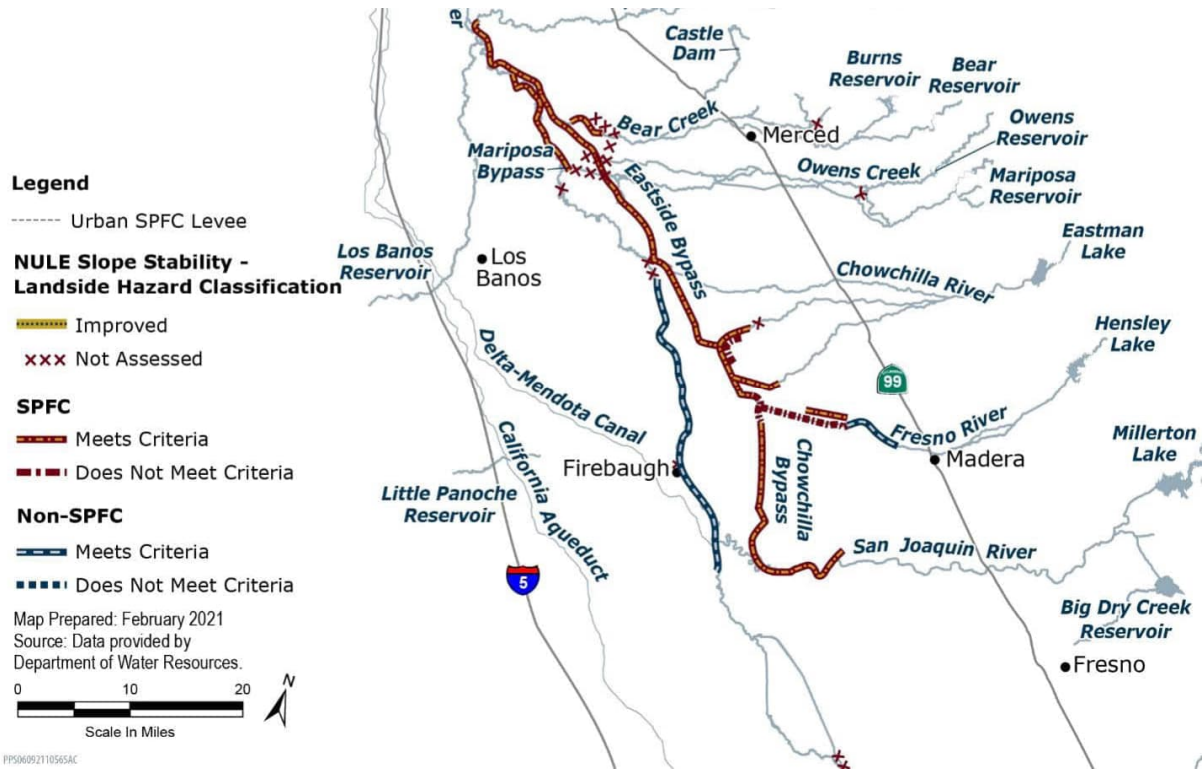
Figure 5-30. Non-Urban Levee Evaluation Project Landside Slope Stability Hazard Classifications

Hazard categories represent a preliminary analysis of levee conditions. During the NULE Project, the hazard categories helped guide subsequent field activities and prepare preliminary remedial alternatives (and associated cost estimates) necessary for levee repairs and improvements to attain acceptable levee performance. Figure 5-30 shows results of FSSR NULE landside slope stability hazard classification. The majority of District sections meet criteria, with a small section on Ash Slough and the Fresno River having conditions that do not meet criteria. “Does Not Meet Criteria” is considered hazardous and shows potential for levee failure.

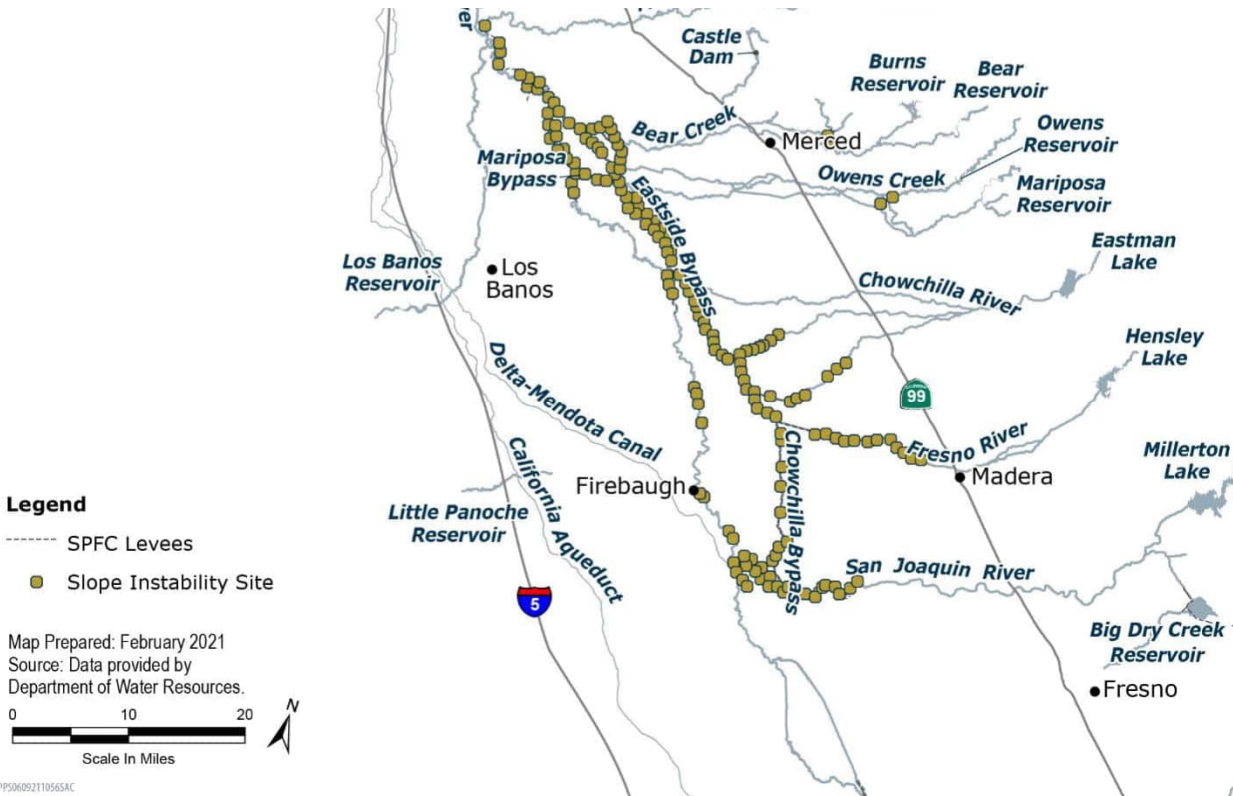
Figure 5-31. Historical Slope Instability

Figure 5-31 depicts locations of historical slope instability. Locations are spread throughout the system, with the Chowchilla Bypass having less historical slope stability. DWR has installed revetment and riprap through DWR’s Levee Repairs Program for a portion of the sites that have been identified.

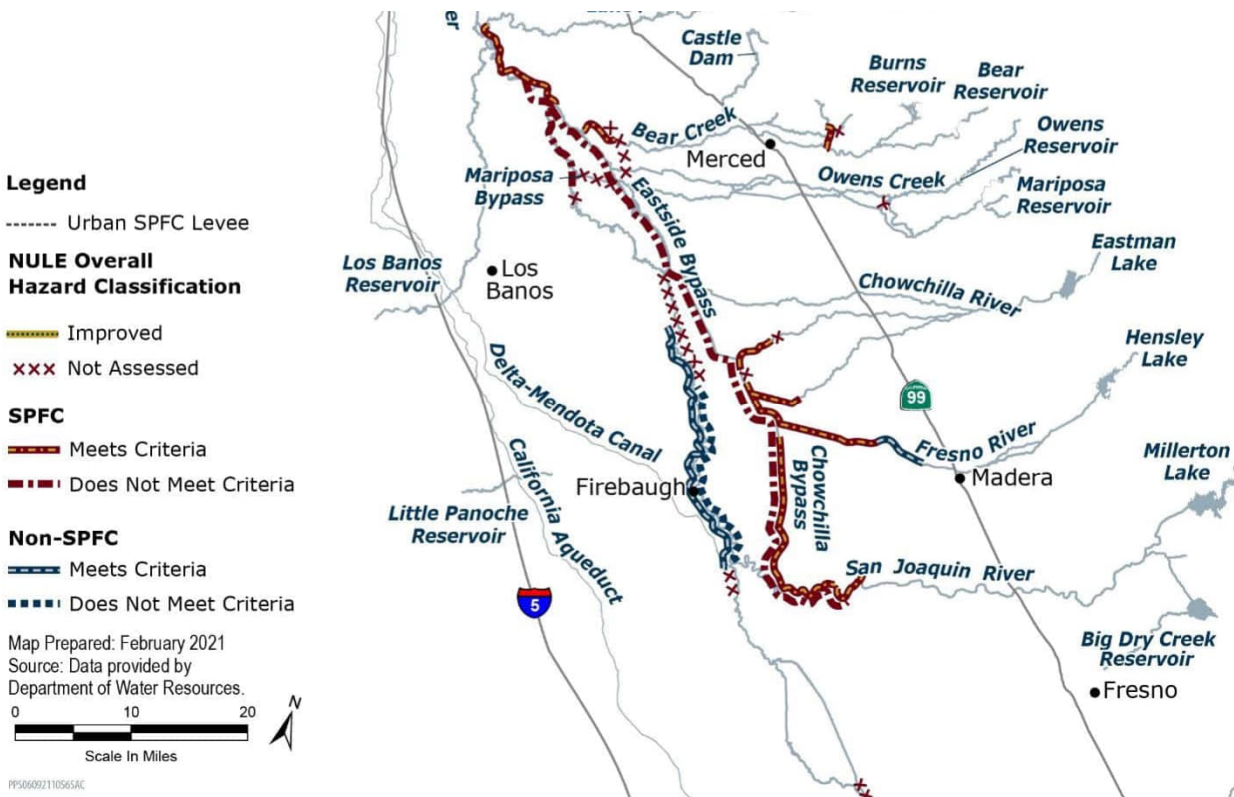
Figure 5-32. Overall Hazard Classifications in the District

The 2022 FSSR (DWR 2022b) reported the NULE overall hazard classifications that DWR previously developed using a Levee Assessment Tool to assign a hazard classification based on a combination of geotechnical data and past levee performance. Figure 5-32 shows the District's overall hazard classification and incorporates geometry, freeboard, seepage, and slope stability ratings. "Does Not Meet Criteria" is considered hazardous and shows the potential for levee failure. Table C-1 (Appendix C) summarizes this information. The majority of the system does not meet criteria, with the exception of the right bank from the Eastside Bypass at Ash Slough upstream to the start of the District system on the San Joaquin River.
