Lower San Joaquin River Flood Control Project System Assessment

Regional Flood Management Planning

LOWER SAN JOAQUIN
LEVEE DISTRICT

Executive Summary

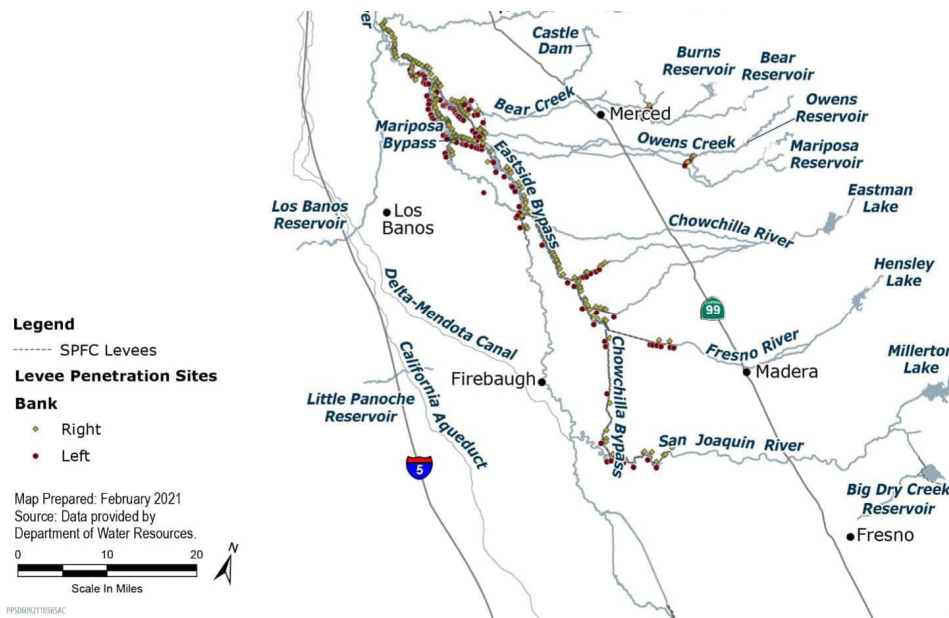
Figure D-1. Levee Penetrations

The Lower San Joaquin Levee District (District) website states there are 328 drainpipes with flap gates through the levees. Figure D-1 shows documented levee penetrations from the *2022 Flood System Status Report Update* (FSSR; DWR 2022). The District has been working with the California Department of Water Resources (DWR) to replace these drainpipes and will continue coordination during future capital system improvement implementation. Because of ongoing maintenance activities and new permit applications, there is a need for continual updates and quality control of the utility crossing inventory database. As new information becomes available, revisiting previous records is necessary so that latest information can be used (DWR 2022).

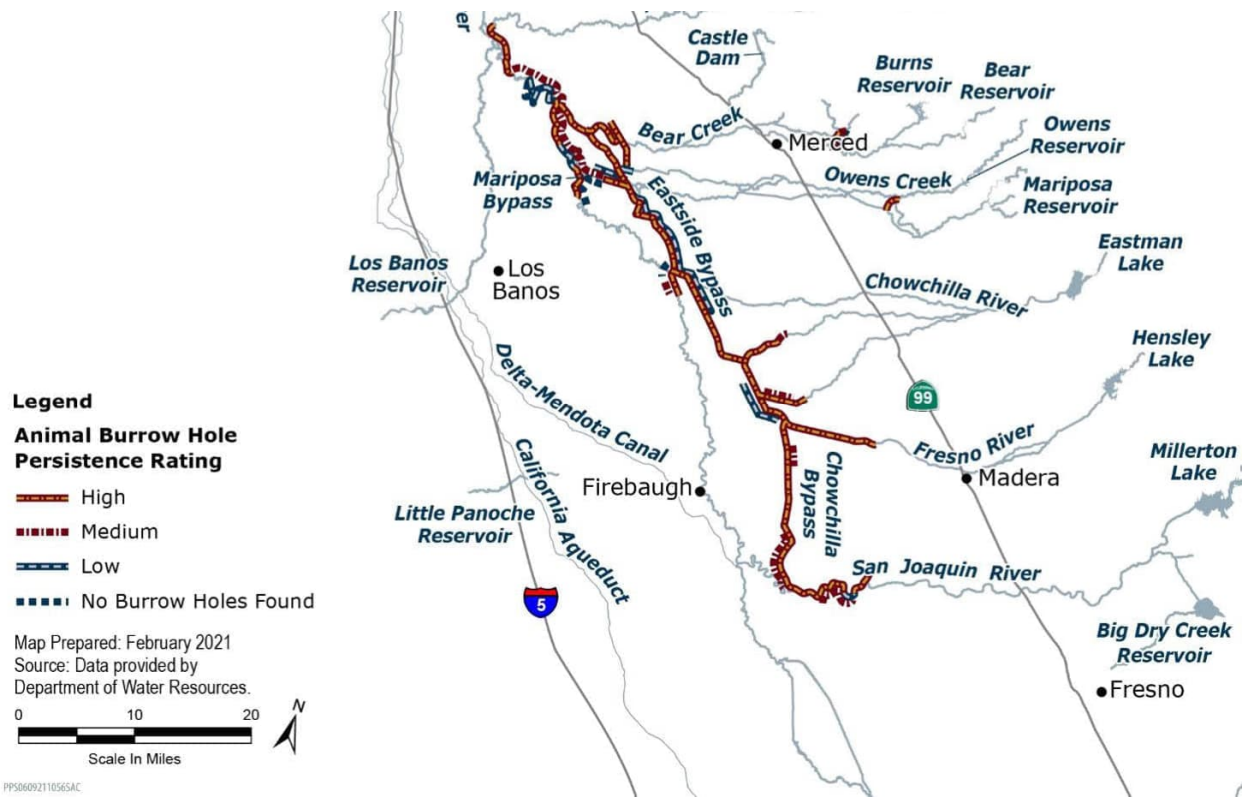
Figure D-3. Animal Burrow Hole Persistence Rating Results

The 2022 FSSR analyzed DWR inspection data on animal burrow hole persistence from 2009 to 2020. Results are shown on Figure D-3, with categorized levels of animal burrow hole persistence (that is, low, medium, and high persistence).

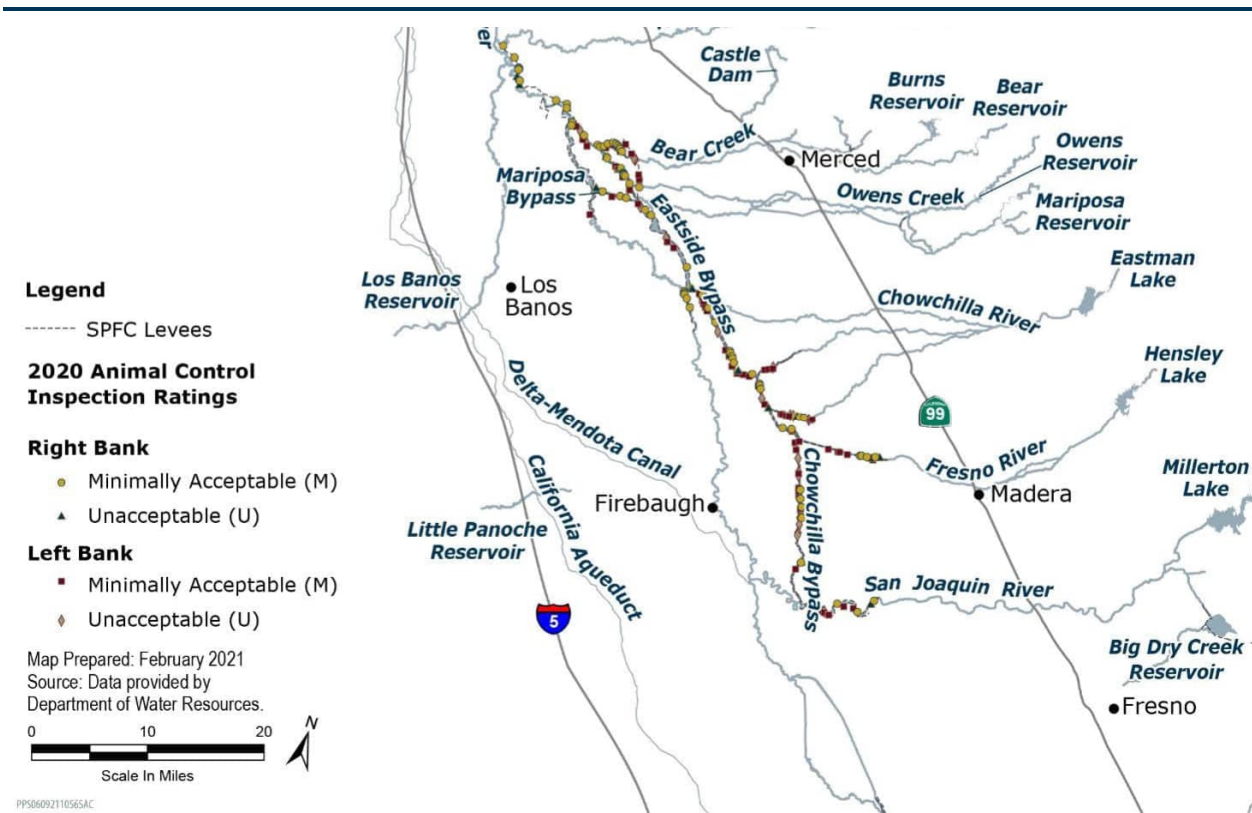
Figure D-4. Animal Control Inspection Rating Results

DWR visually inspects SPFC levees for burrowing animal damage at least twice a year, and reports results annually. Table D-2 shows DWR inspection rating descriptions for animal control of burrowing animals. Figure D-4 shows inspection ratings.
